FINAL REPORT

Review of Previous Pipeline Abandonment Program – Phase 3 Abandonment on Farmland

Pipeline Abandonment
Research Steering
Committee

February 2019

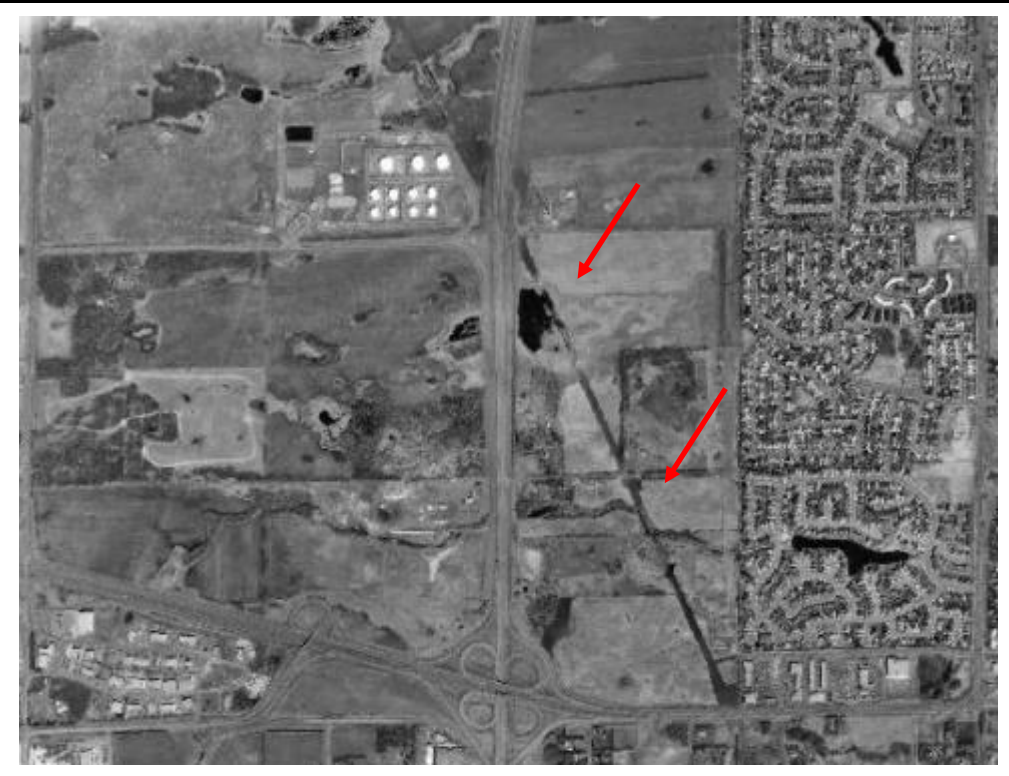
KP 3.1: Watercourse – Goldbar Creek. No concerns identified.

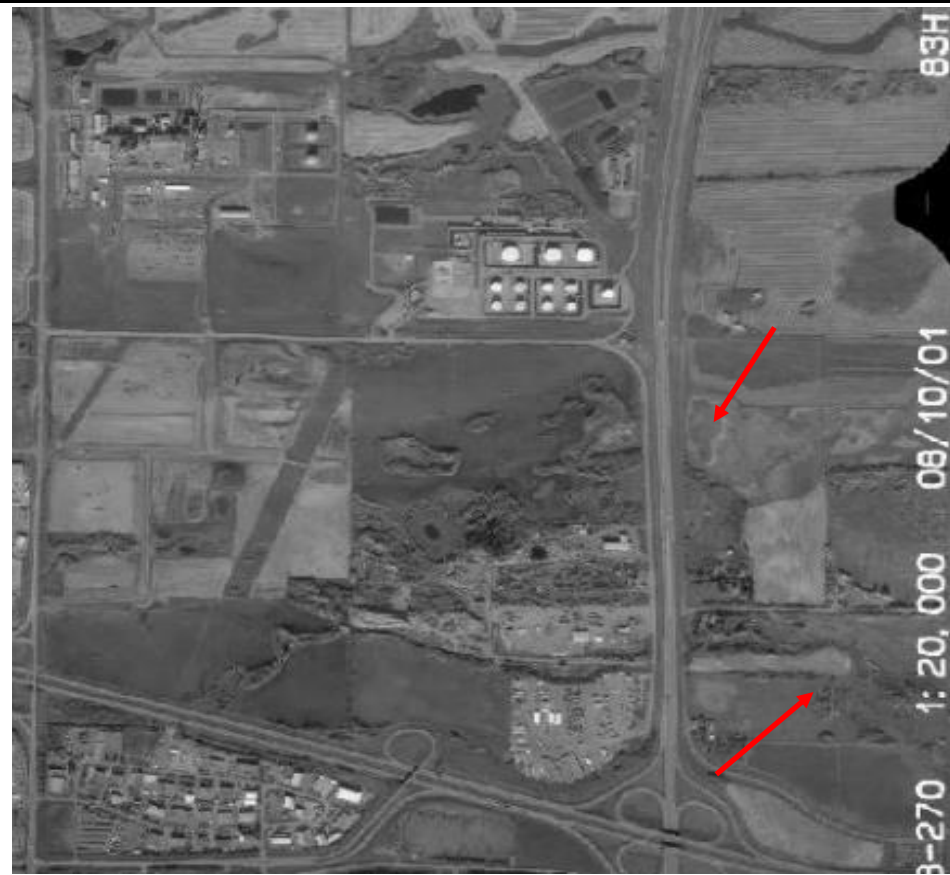
KP 2.2 to KP 2.5: Seasonal graminoid marsh (no previous concerns identified). There is no evidence of alternation of the wetland size or shape in this image.

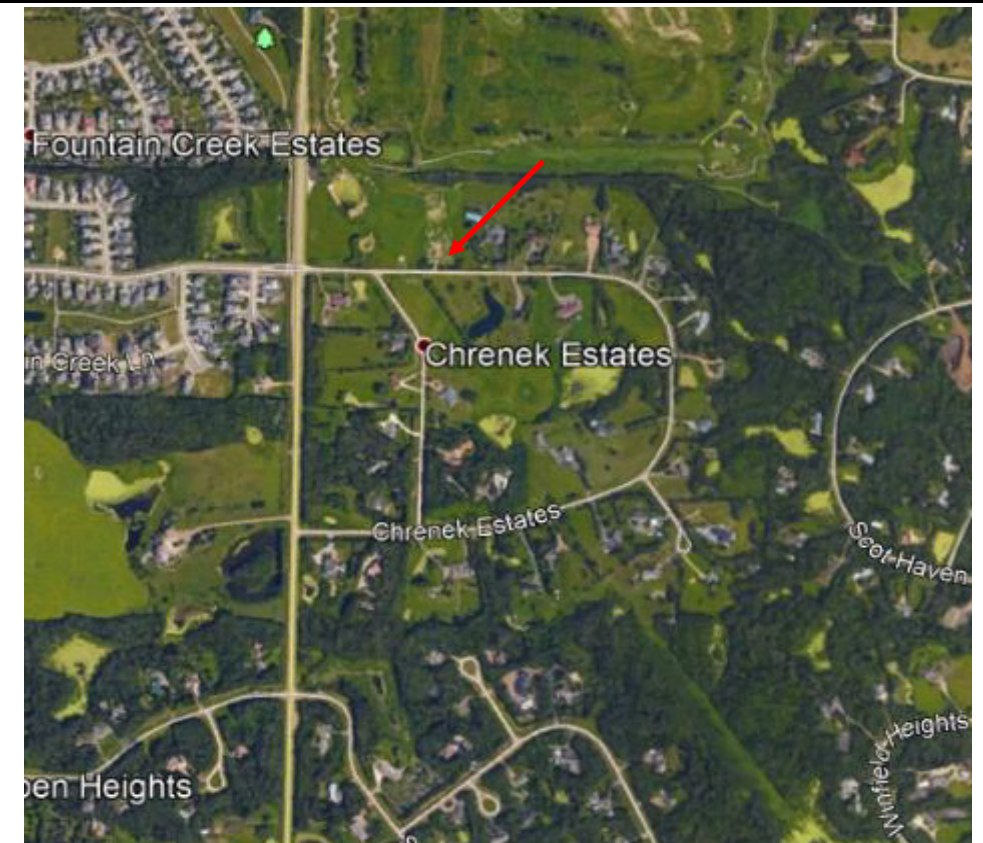
Photoplate: Aerial view of KP 5.7 to KP 6.6: Leak and repair location (Google Earth, September 29, 2018). This image was taken approximately 45 years after the leak occurred.

Site Description	Legal Location (W4M) (Approximate UTM 12U)	Additional Testing
1979 leak and repair location	NW 15-52-23 (346210E 5930078N)	<ul style="list-style-type: none"> Review site records from cleanup to determine if the compounds described in NOVA Chemicals' Fate and Decomposition of Pipe Coating Materials in Abandoned Pipelines (2015) and Thorne et al.'s Trace Contaminants in Oil and Gas Pipelines (1996) were found.
Highway crossing (Highway 628)	SE 15 and NE 10-52-23 (347286E 5928460N)	<ul style="list-style-type: none"> Excavate abandoned pipe under a small portion of the road and assess it for evidence of corrosion to determine if access over the abandoned pipe has caused it to de-aerate and become anodic, as described in DNV's Understanding the Mechanisms of Corrosion and their Effects on Abandoned Pipelines (2015). Request municipal road maintenance records to determine if there is historical evidence of subsidence or if any additional maintenance was required to address subsidence or erosion concerns.

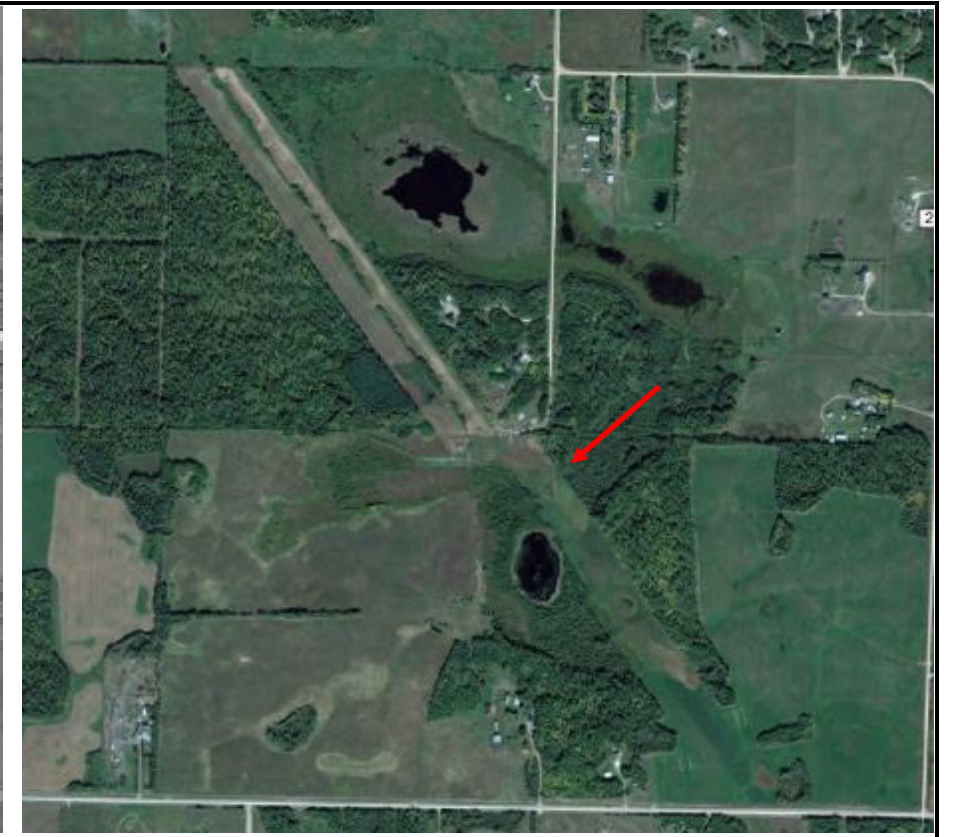
Photoplate: Aerial view of gully erosion area noted in 2016. (Google Earth, September 29, 2018). This image was taken approximately 38 years after the abandonment of Segment 1A.

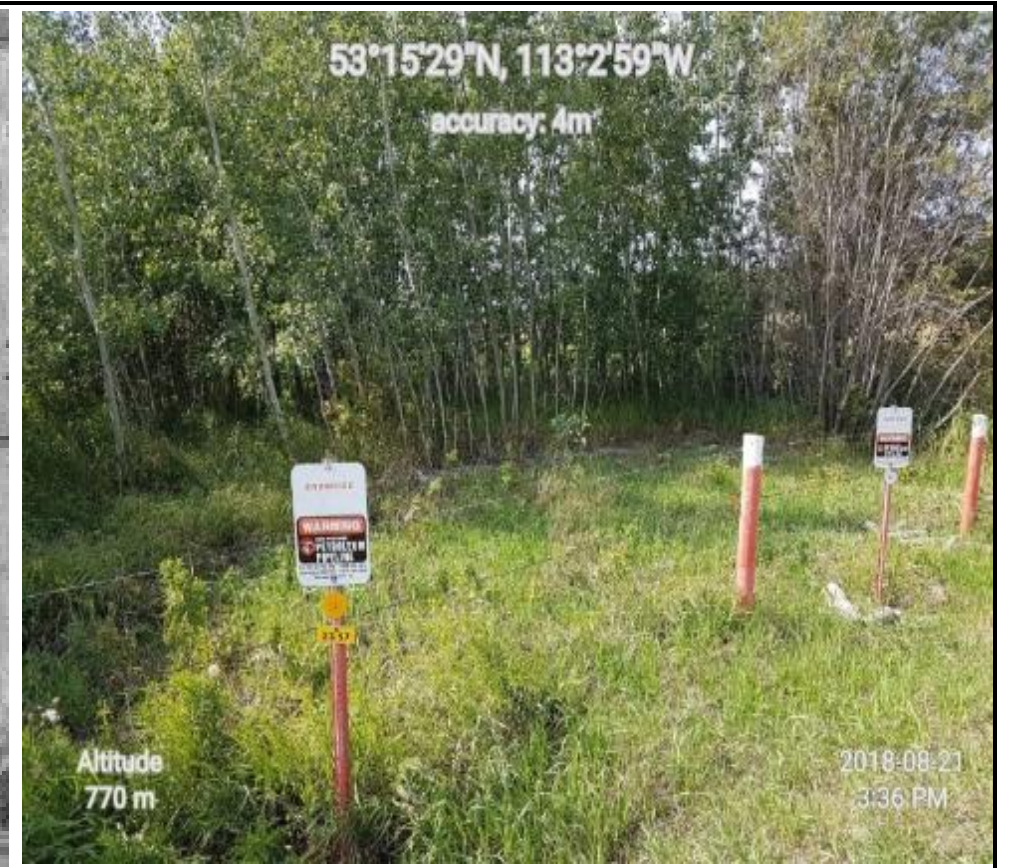
Photoplate: View northwest of abandoned pipeline segment showing tree regrowth adjacent to a road crossing near KP 38.2 at NE 30-49-22 W4M (12U 363272E 5902937N). This image was taken approximately 38 years after the abandonment of Segment 1A.

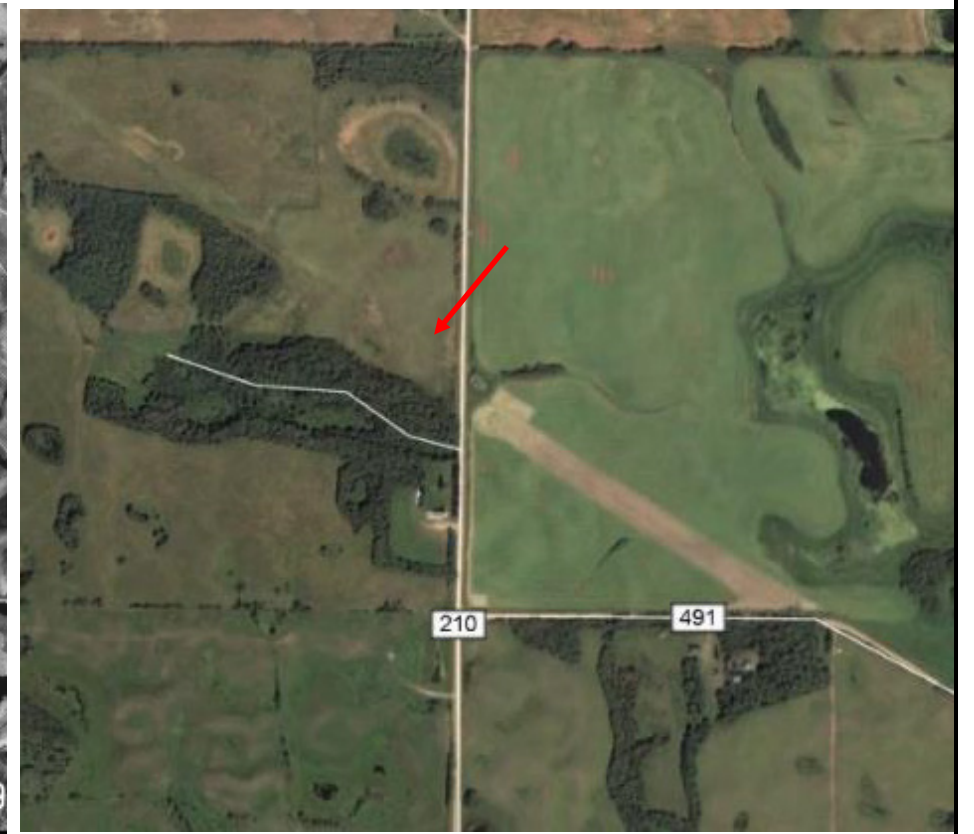
Photoplate: Aerial view of subsidence area (Google Earth, 2018). This image was taken approximately 38 years after the abandonment of Segment 1A.

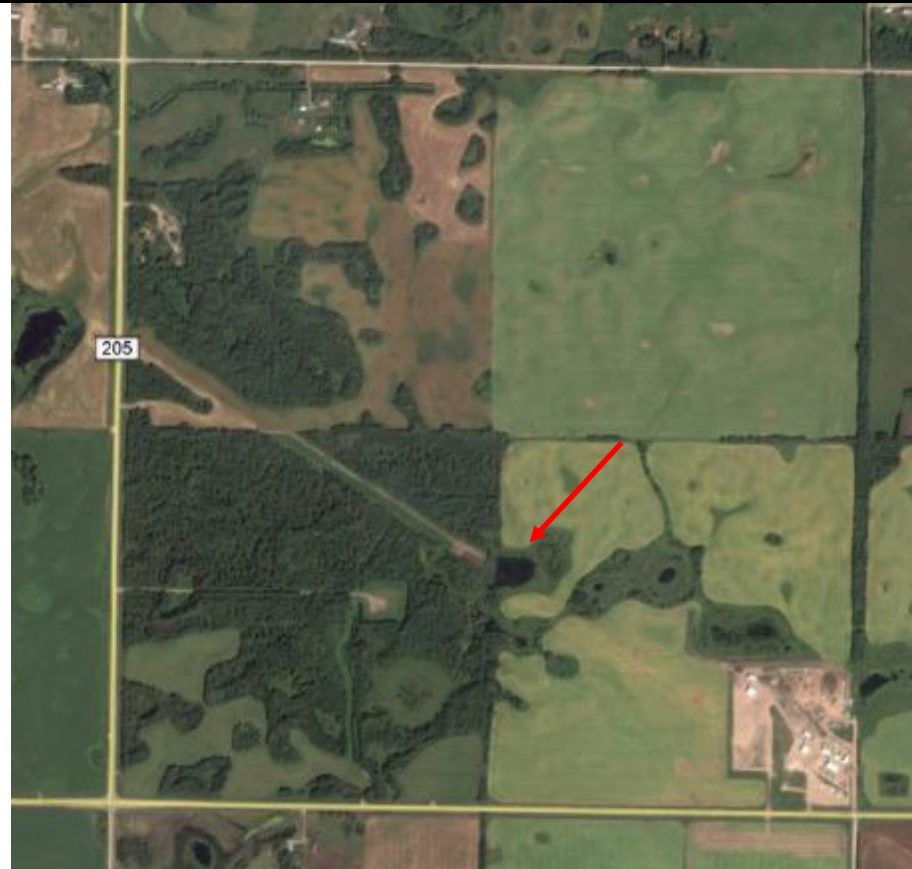
Photoplate: Aerial view of corrosion repair area (Google Earth, September 29, 2018). This image was taken approximately 38 years after the abandonment of Segment 1A and 32 years after the completion of the corrosion inspection and repair work.

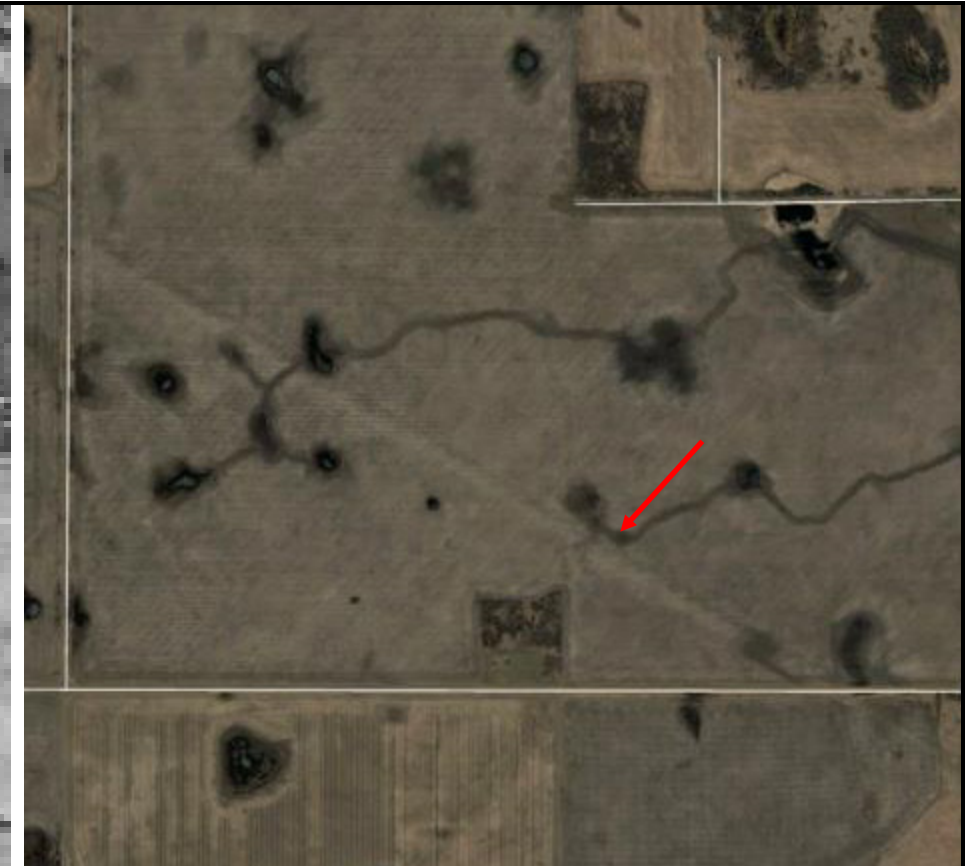
Photo-plate: Aerial view of subsidence area (Google Earth, September 29, 2018). This image was taken approximately 38 years after the abandonment of Segment 1B.

Subsidence issue observed and repaired in 2016, and road crossing	SE 29-45-14 (433199E 5861798N)	<ul style="list-style-type: none"> Excavate abandoned pipe under a small portion of the road and assess it for evidence of corrosion to determine if access over the abandoned pipe has caused it to de-aerate and become anodic, as described in DNV's Understanding the Mechanisms of Corrosion and their Effects on Abandoned Pipelines (2015).
Cathodic protection (ground bed location identified on as-builts) and road crossing	SW 22-45-14 (430411E 5863493N)	<ul style="list-style-type: none"> Excavate the pipe and determine the presence or absence of cathodic protection test leads. Assess the condition of the excavated pipe in relation to the presence or absence of cathodic protection. Observe areas around cathodic protection for potential decay, as informed by PARSC 019, when complete. Collect soil samples and test for metallic by-products of cathodic protection breakdown, as informed by PARSC 019, when available.

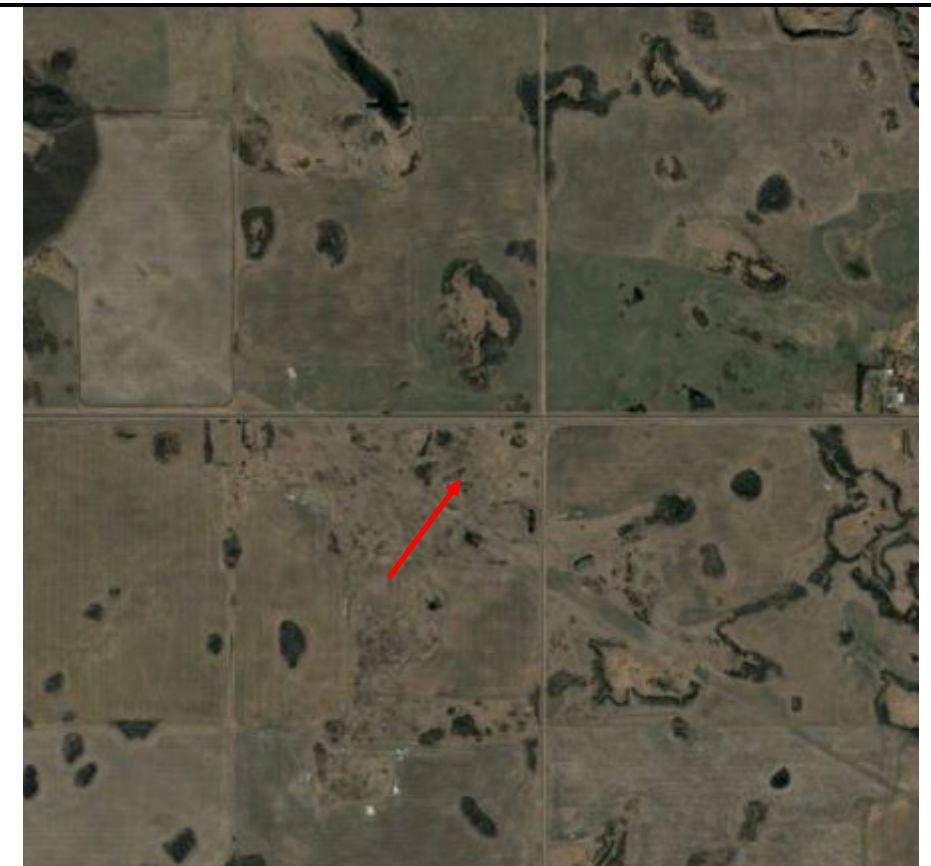
Photoplate: Aerial view of temporary marsh area (Google Earth, September 29, 2018). There is evidence of the formation of additional wetlands adjacent to the pipeline corridor that may represent preferential drainage along the outside of a pipeline. However, given that the abandoned Segment 1B is collocated in a corridor with other active pipelines, the formation of these wetlands cannot be conclusively attributed to Segment 1B. Additionally, there was a significant amount of precipitation (i.e., snow and rain fall) in September 2018, that may have contributed to the accumulation of water in depressions adjacent to the pipeline corridor.
