REM Technology Inc.

Field Evaluation of the REMVue® LHP Technology

Final Report - Revision 2.0

Submitted to PTAC - April 10, 2012

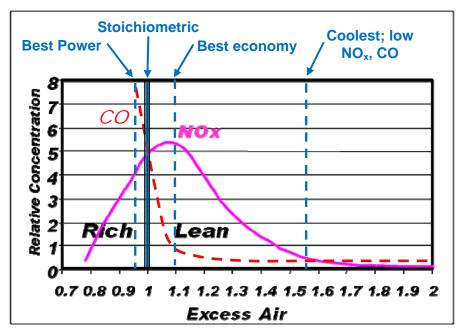
Figure 1: Effect of Excess Air on NO_x and CO Emissions

Studies show that, in comparison to stoichiometric operation, lean operation (excess air) provides better fuel efficiency and lower exhaust temperatures that result in improved reliability. Lean operation with more than 1.15 times the amount of air needed for full combustion reduces the NO_x and CO emissions, refer to Figure 1.

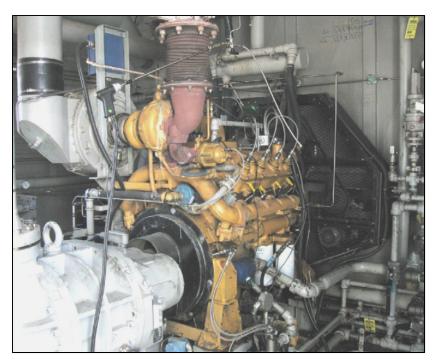
Figure 5: Caterpillar G3408 TA

Prior to the installation of the higher-energy ignition system the engine was unable to reliably ignite airfuel mixtures leaner than $6.0 \% O_2$. With the higher-energy ignition in place the lean operating limit was extended beyond $7.5 \% O_2$. Insufficient excess air prevented a true determination of the lean operating limit.

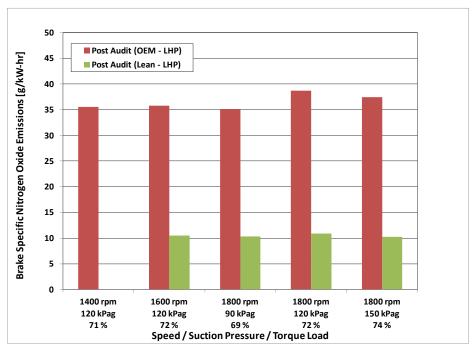
Figure 6: Brake Specific Nitrogen Oxide Emissions - Caterpillar G3408 TA

Figure 6 shows the impact of lean operation at $7.1-7.2~\%~O_2$ on reducing BSNO_x emissions. For this engine substantial reduction in NO_x emissions was observed relative to the OEM test case. A plot of the engine's BSFC for the different test cases is shown in Figure 7. With lean operation a 3-5~% improvement in fuel efficiency is observed throughout the range of operating conditions tested relative to the OEM test case.

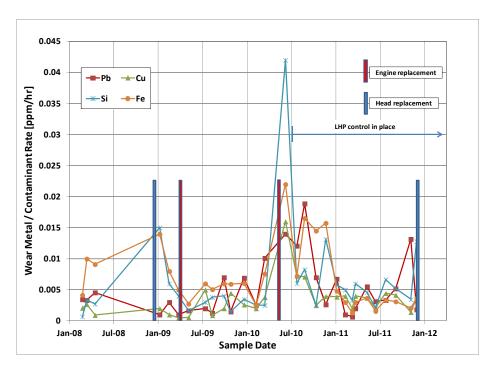
Figure 8: Selected Engine Wear Metals and Contaminants - Caterpillar G3408 TA

A graphical representation of oil analysis wear metals and contaminants for this engine is shown in Figure 8.

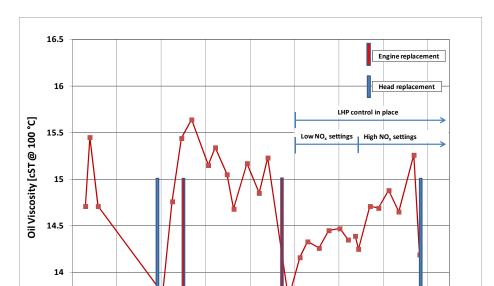
Figure 9: Oil Viscosity - Caterpillar G3408 TA

Figure 9, oil viscosity shows a reduction in viscosity with the lower NO_x operation of the LHP technology.

As noted previously, the reduced NO_x associated with lean operation is coincident with a drop in oil viscosity due to reduced oil nitration.

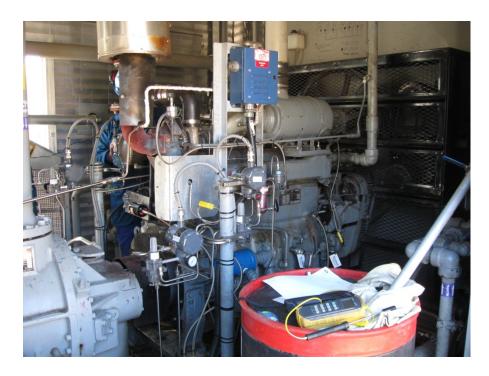
Figure 10: Waukesha F11 GSI

The Waukesha F11 GSI is an open chamber rich burn engine (see Table 3 for OEM ratings). A picture of the engine is shown in Figure 10. The engine is typically operated at the following conditions:

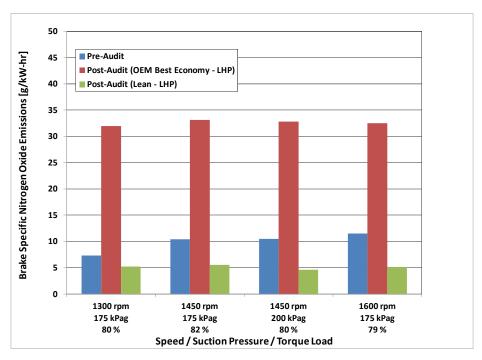
Figure 11: Brake Specific Nitrogen Oxide Emissions - Waukesha F11 GSI

Plots of BSNO $_x$ and BSFC are shown in Figure 11 and Figure 12, respectively. With lean operation at 7.0 to 7.2 % O_2 , fuel efficiency improvements of 6 – 15 % and NO_x emission reductions of 30 – 55 % are realized relative to the pre-audit baseline. Even with the additional advance and various system upgrades present for the post-audit testing at the OEM best economy operating point, lean operation shows comparable fuel efficiency and an 80 % reduction in NO_x emissions. Furthermore, Figure C22 demonstrates that average exhaust gas temperatures are reduced by approximately 70 °C compared to operation at best economy. Exhaust gas temperature measurements were not available for the preaudit baseline test, however, similar reductions in the exhaust gas temperature would be expected.

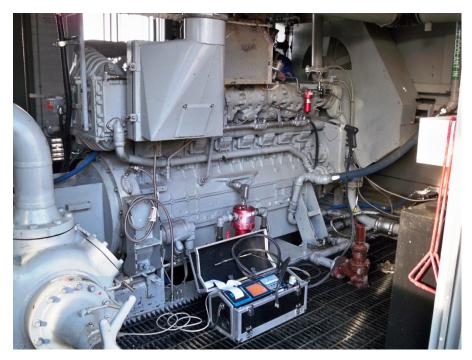
Figure 13: Waukesha H24 GL

Unlike the other engines in this study, the Waukesha H24 GL is an open chamber lean burn engine (see Table 5 for OEM ratings). A picture of the engine is shown in Figure 13. The LHP technology was applied to this engine to improve the air-fuel control compared to the existing carburetor.

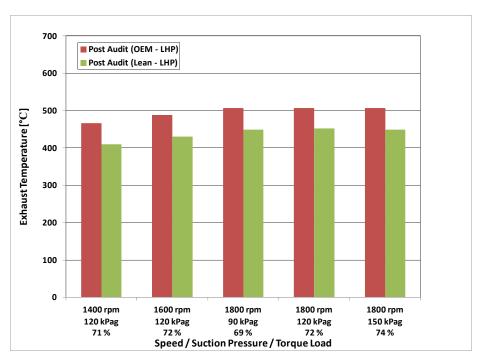
Figure B18: Exhaust Gas Temperature - Caterpillar G3408 TA

A reduction in exhaust gas temperature of $50-60\,^{\circ}\text{C}$ compared to the OEM test case occurred, see Figure B18. As Caterpillar G3400 series engines are known for their high cylinder head failure rate the reduction in exhaust gas temperatures and potential for reduced oil nitration with very lean operation should extend cylinder head service intervals.

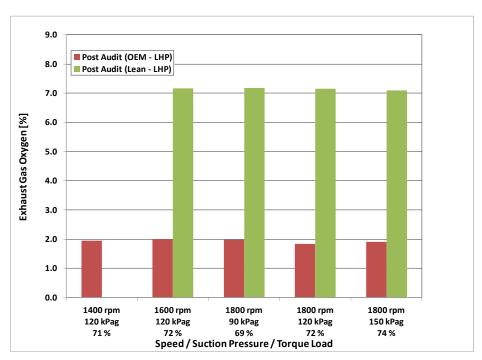
Figure B19: Exhaust Gas Oxygen - Caterpillar G3408 TA

Because the existing turbocharger could not deliver sufficient excess air to reach the desired NO_x emissions of 6.0 g/kW-hr, the engine was configured to achieve a balance between NO_x emissions reduction and engine fuel efficiency improvement. Figure B19 shows the exhaust gas oxygen percentage.

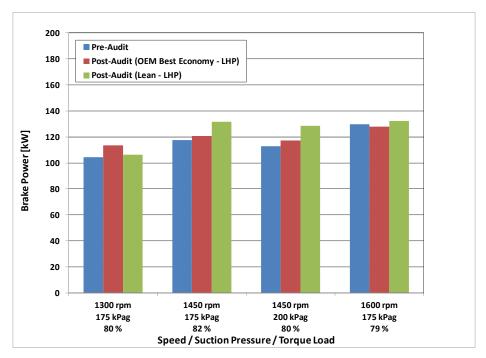
Figure C20: Brake Power - Waukesha F11 GSI

The test configuration and test points for the unit are provided in Table 4 and Table C15, respectively. Comparisons of the engine power and manifold air temperatures for the test points are provided in Figure C20 and Figure C21 for reference.

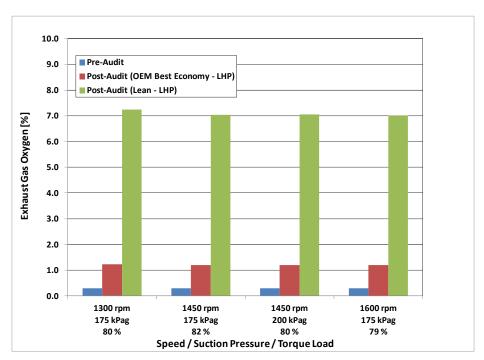
Figure C23: Exhaust Gas Oxygen - Waukesha F11 GSI

Figure C23 shows that the LHP system is able to maintain the exhaust gas oxygen within 0.1 %. This translates to good NO_x control over the range of engine operating conditions.
