FINAL REPORT

Review of Previous Pipeline Abandonment Program – Phase 3 Abandonment on Farmland

Pipeline Abandonment
Research Steering
Committee

February 2019

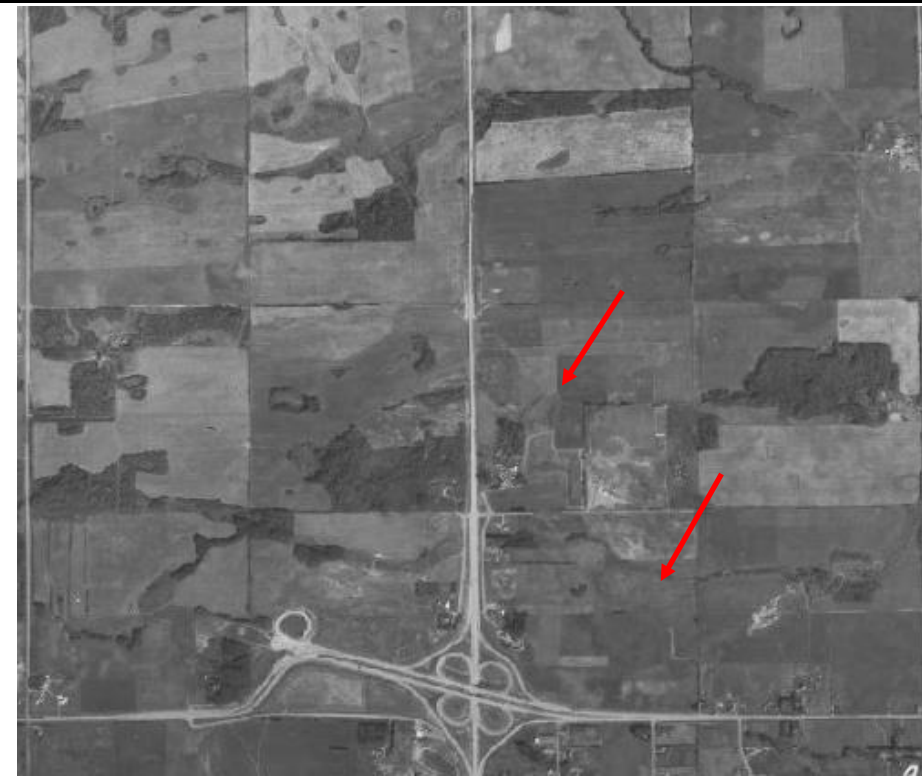
Historic Aerial: 32-52-23 W4M, August 15, 1967 (Image AS979). This image was taken approximately 13 years prior to the abandonment of Segment 1A.

Kilometre Post (KP) 2.2 to KP 2.5: Seasonal graminoid marsh. While there is evidence of less water than in later years, it is not uncommon for a seasonal marsh to have little or no water remaining in the late summer. Seasonal marshes are defined as mineral wetlands that are typically flooded for the growing season but have little to no surface water remaining by the end of the summer (Alberta Environment and Sustainable Resource Development, 2015)

KP 3.1: Watercourse – Goldbar Creek. No concerns identified.

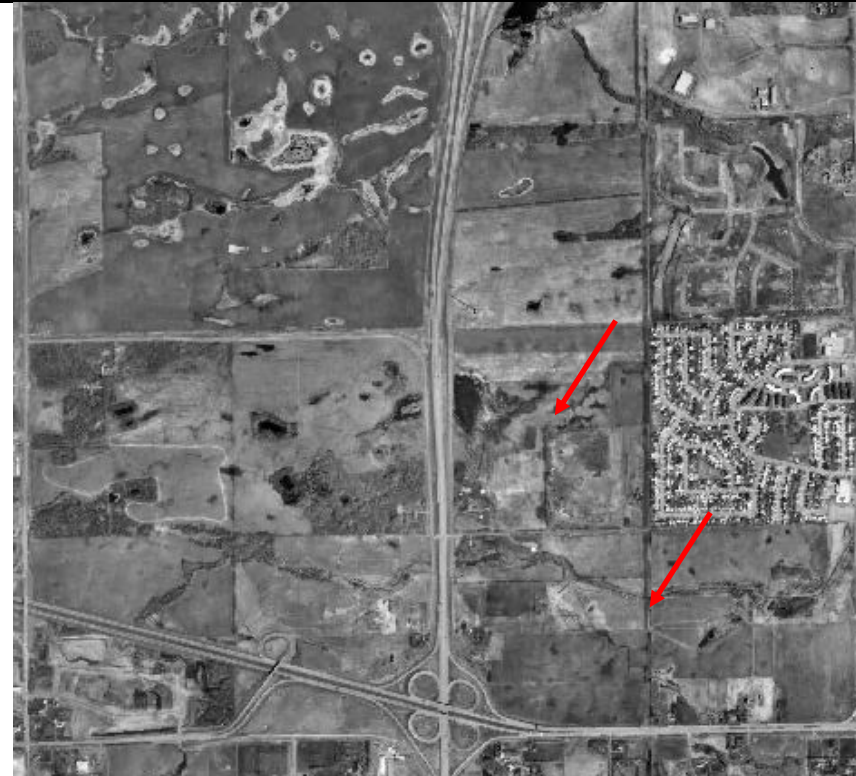
Historic Aerial: 28-52-23 W4M, May 5, 1978 (Image AS2944). Segment 1A of the Line 3 pipeline was still operational at this time.

KP 2.2 to KP 2.5: Seasonal graminoid marsh (no previous concerns identified). There appears to be more water in the wetland than in the 1967 photograph, but this cannot be conclusively attributed to the construction of the Line 3 Pipeline since there is evidence of other development (i.e., a residential area) in the surrounding landscape.

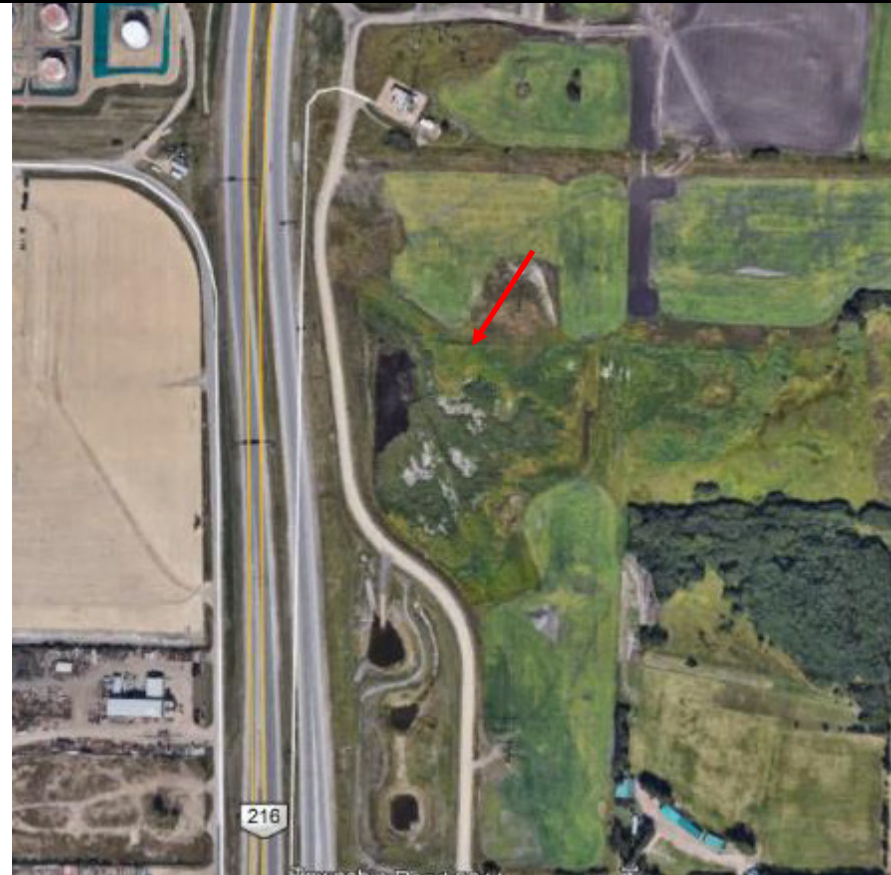
Photoplate: Aerial view of the seasonal graminoid marsh (Google Earth, August 25, 2018). Segment 1A of the Line 3 Pipeline has been abandoned for approximately 38 years, at this time.

KP 2.2 to KP 2.5: Seasonal graminoid marsh (no previous concerns identified). There is no evidence of alternation of the wetland size or shape in this image.

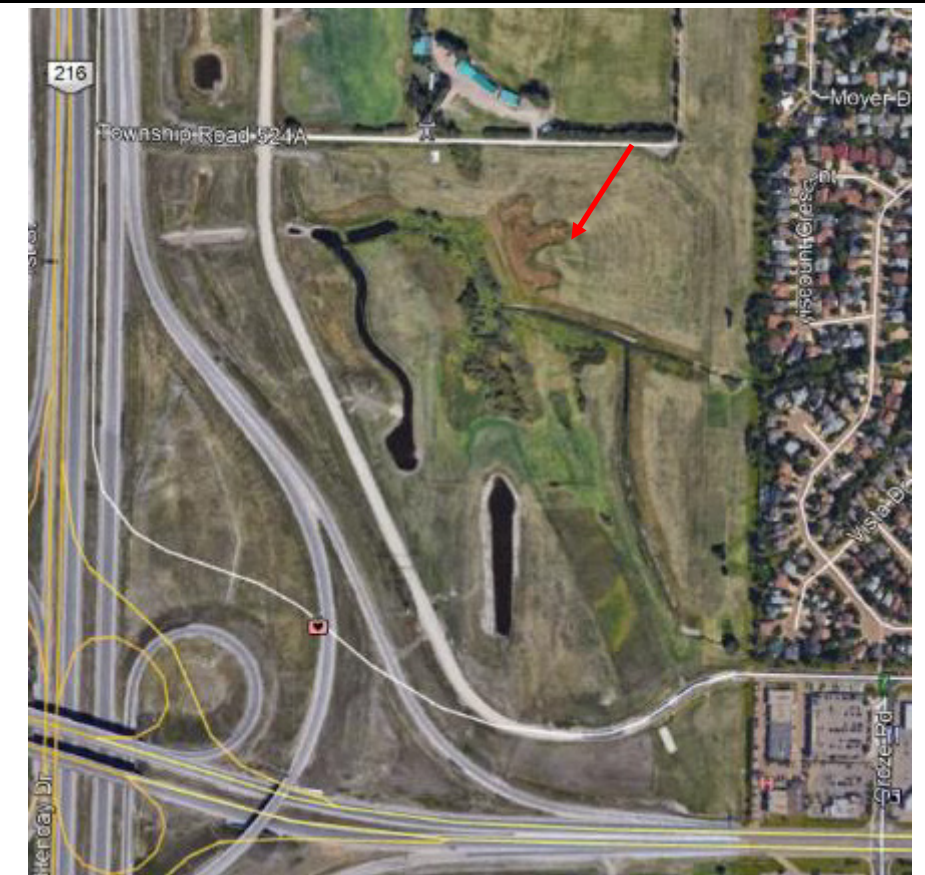
Photoplate: Aerial view of Goldbar Creek (Google Earth, August 25, 2018). The creek was re-aligned within the Transportation/Utility Corridor within the last 3 years as a result of multiple utility expansion projects sharing the space.

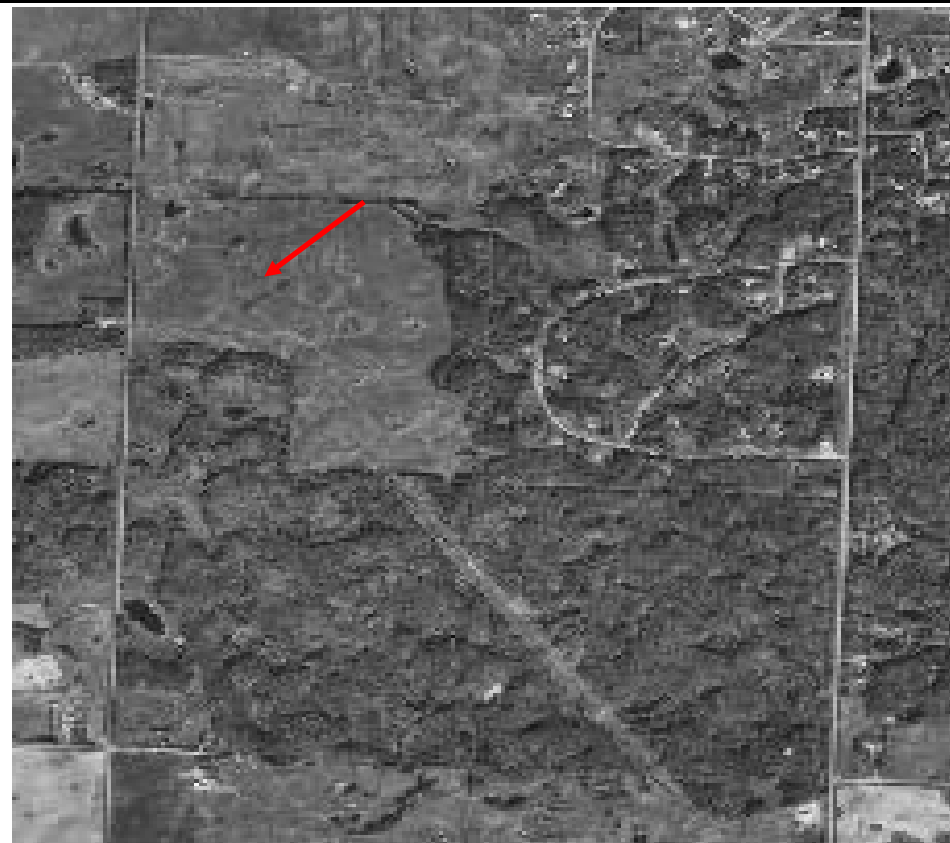
Historic Aerial: 15 and 10-52-23 W4M, September 15, 1973 (Image AS1250). This image was taken approximately 7 years prior to the abandonment of Segment 1A.

KP 5.7 to KP 6.6: 1979 leak and repair location. This image was taken prior to the leak occurrence.

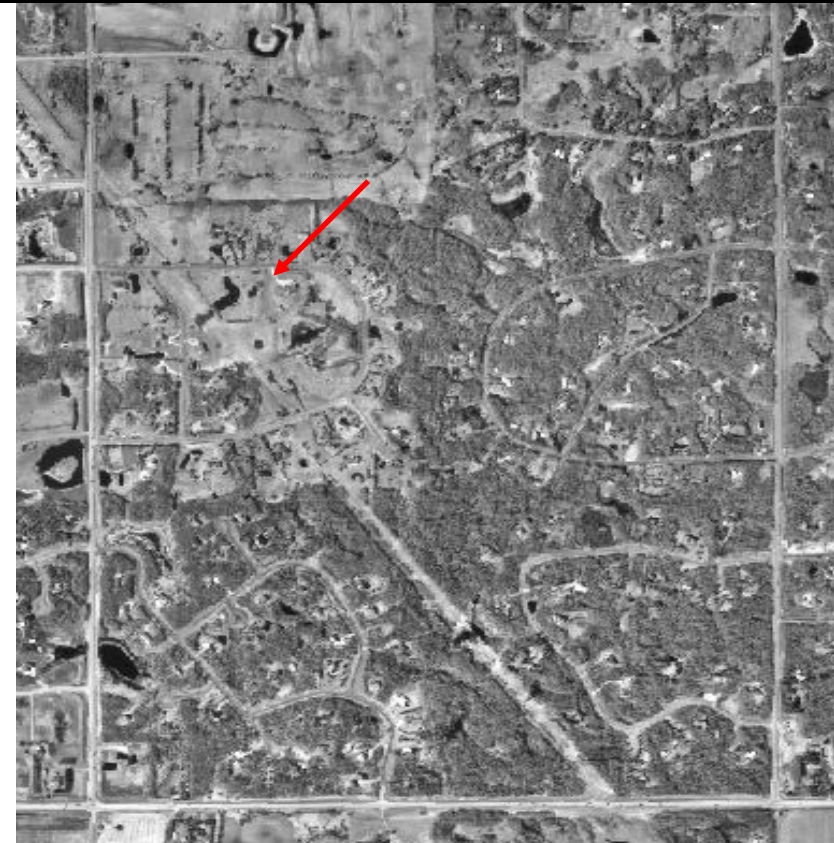
Historic Aerial: 15 and 10-52-23 W4M, May 4, 2005 (Image ED2005_2). This image was taken approximately 26 years after the leak occurred.

KP 5.7 to KP 6.6: 1979 leak and repair location. No site-specific investigations were conducted for the review of a previous pipeline abandonment program – Enbridge Line 3 Mainline pipeline (the Project); however, the Spill Report for this site indicated that the spill was cleaned up to the previous land capability and to landowner satisfaction.

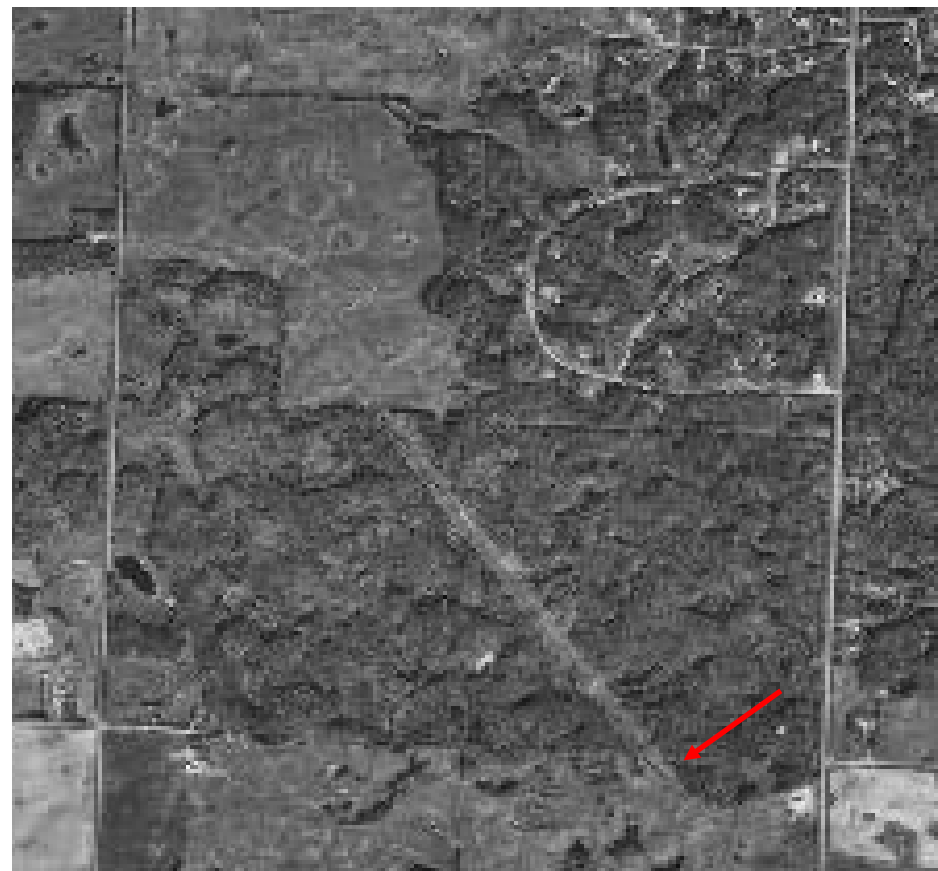
Historic Aerial: 15 and 10-52-23 W4M, September 15, 1973 (Image AS1250). This image was taken approximately 7 years prior to the abandonment of Segment 1A.

KP 7.6 to KP 7.7: Highway crossing location, the pipeline ROW is evident, but the highway does not appear to have been constructed yet.

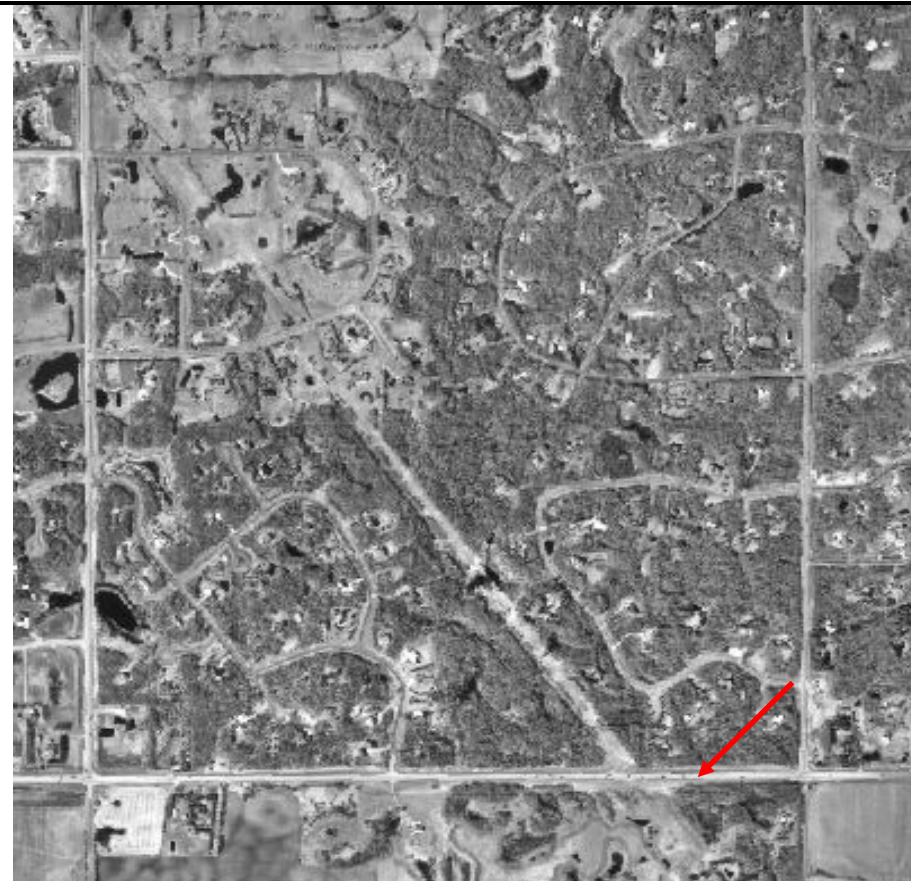
Historic Aerial: 15 and 10-52-23 W4M, May 4, 2005 (Image ED2005_2). This image was taken approximately 25 years after the abandonment of Segment 1A.

KP 7.6 to KP 7.7: Highway crossing. There does not appear to be any evidence of subsidence at this secondary highway crossing.

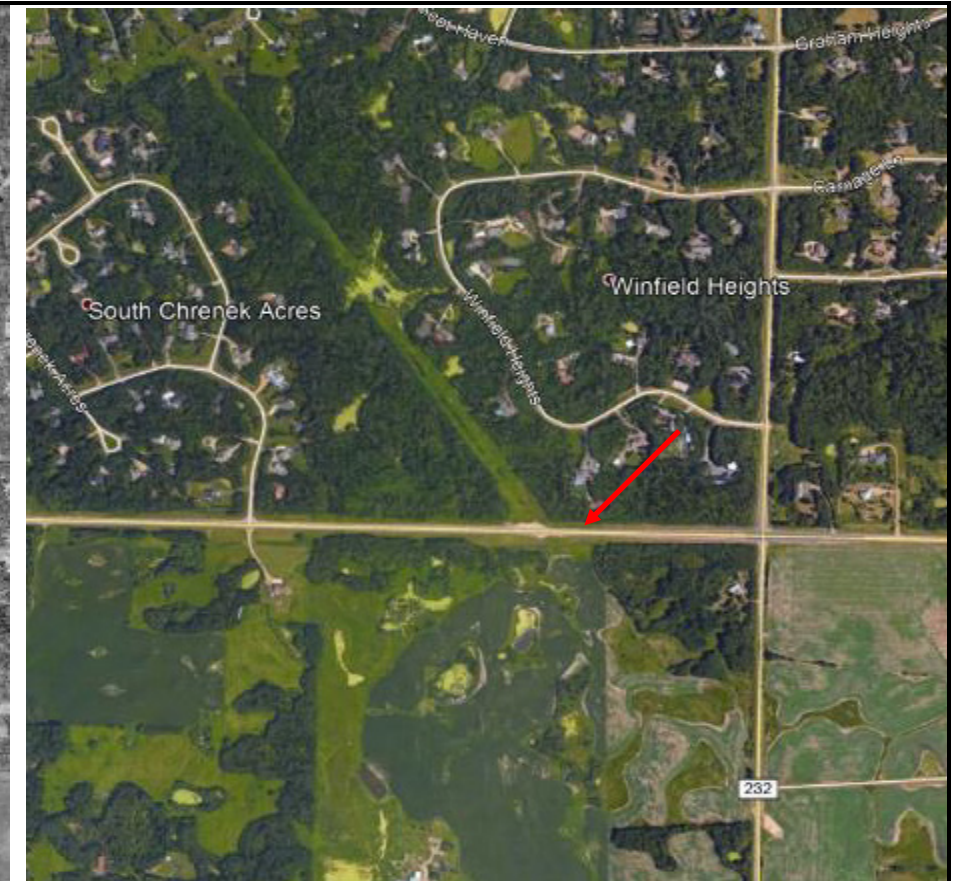
Photo-plate: Aerial view of Highway 628 crossing near KP 7.6 to KP 7.7 (Google Earth, September 29, 2018). This image was taken approximately 38 years after the abandonment of Segment 1A.

There appears to be evidence of work along the ROW that should be investigated at the ground level and through requesting municipal road repair records for this location.

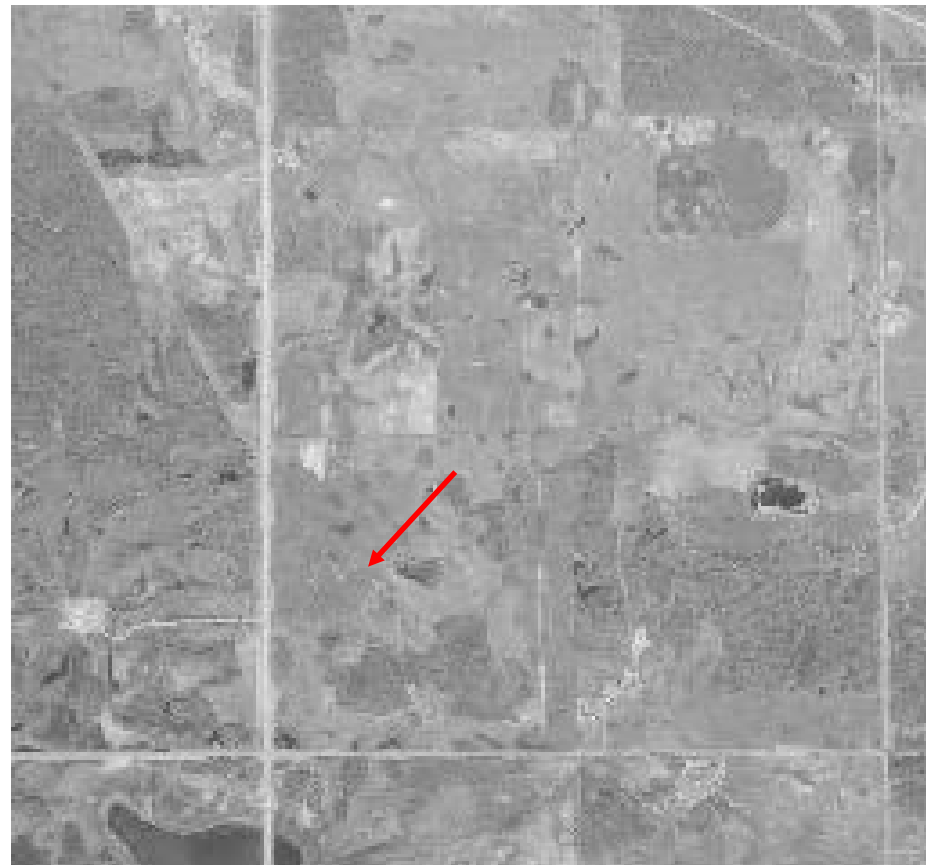
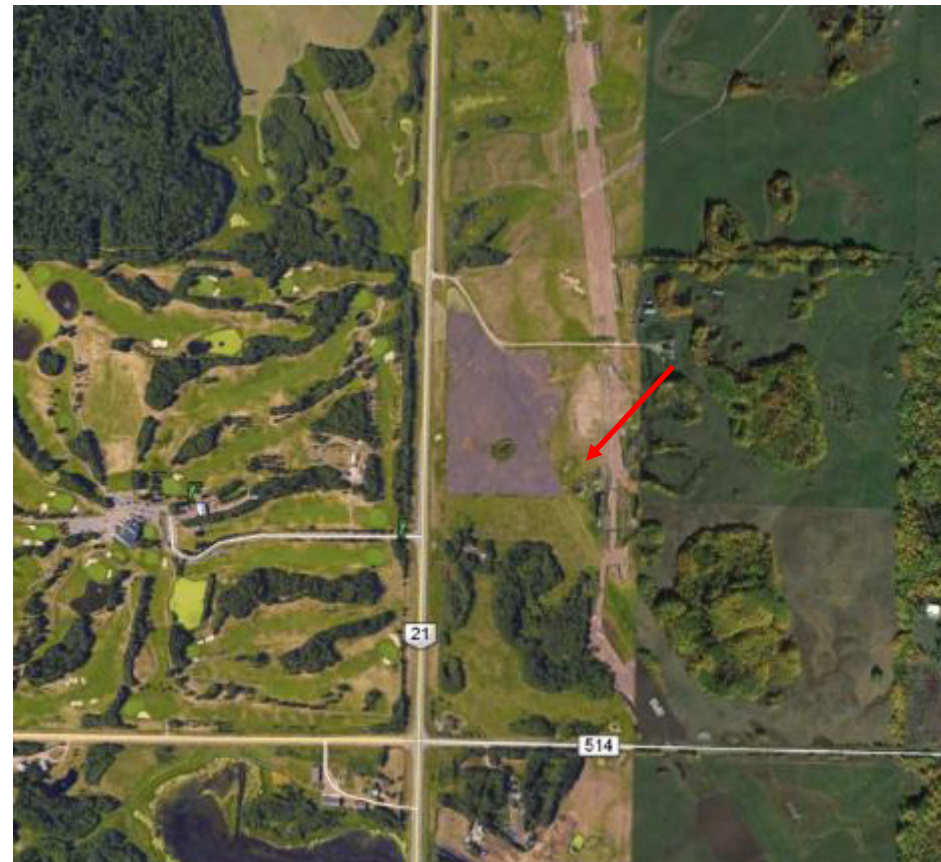
Historic Aerial: 30 and 19-51-22 W4M, May 26, 1962 (Image AS819). This image was taken approximately 18 years prior to the abandonment of Segment 1A.

KP 14.9 to KP 15.1: Area of subsidence noted in 2016, repaired in 2017 (contouring issue). The pipeline ROW is evident across the quarter-section, but the subsidence issue was not noted until the construction of another pipeline within the corridor was completed.

From this image, it appears that the entire pipeline corridor was remediated, so it is unclear if the subsidence was along the abandoned Line 3 ROW or along another ROW in the corridor.

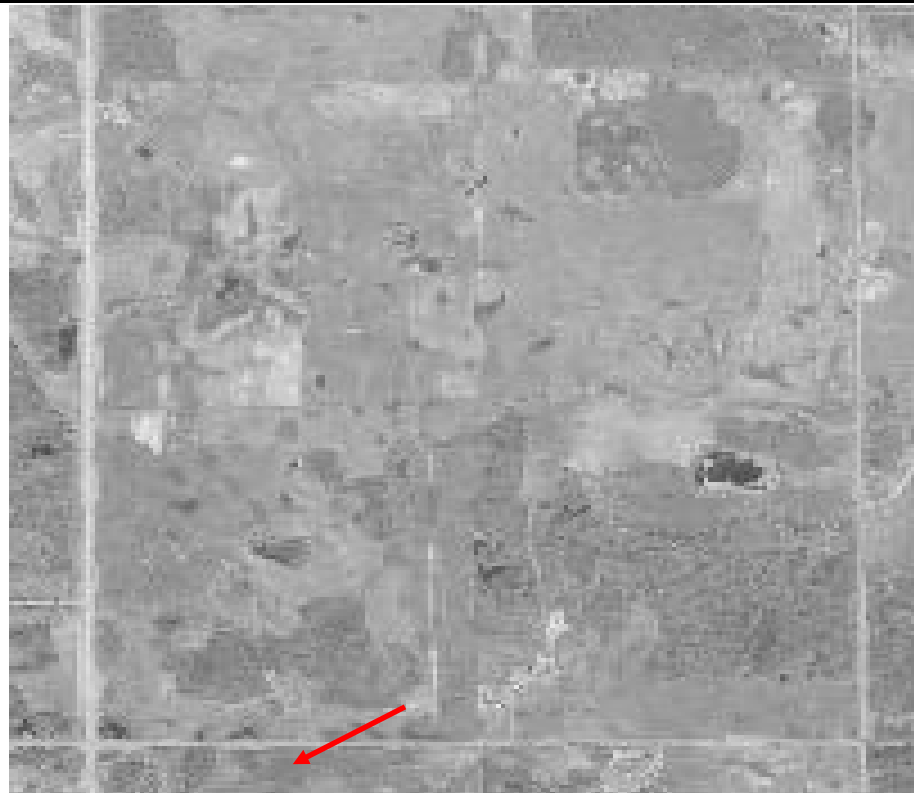
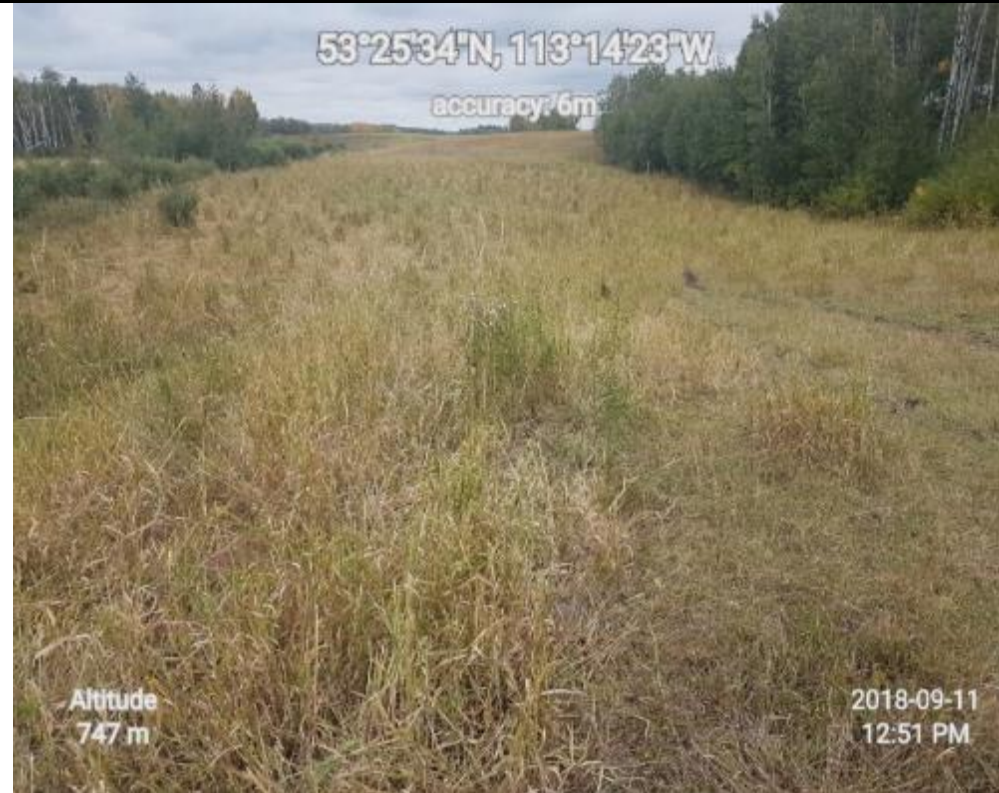
Historic Aerial: 30 and 19-51-22 W4M, May 26, 1962 (Image AS819). This image was taken approximately 18 years prior to the abandonment of Segment 1A.

KP 15.4 to KP 15.5: Seasonal graminoid marsh (issue with bare ground and poor vegetation regrowth noted in 2016 and 2017 along other pipeline segments in the ROW).

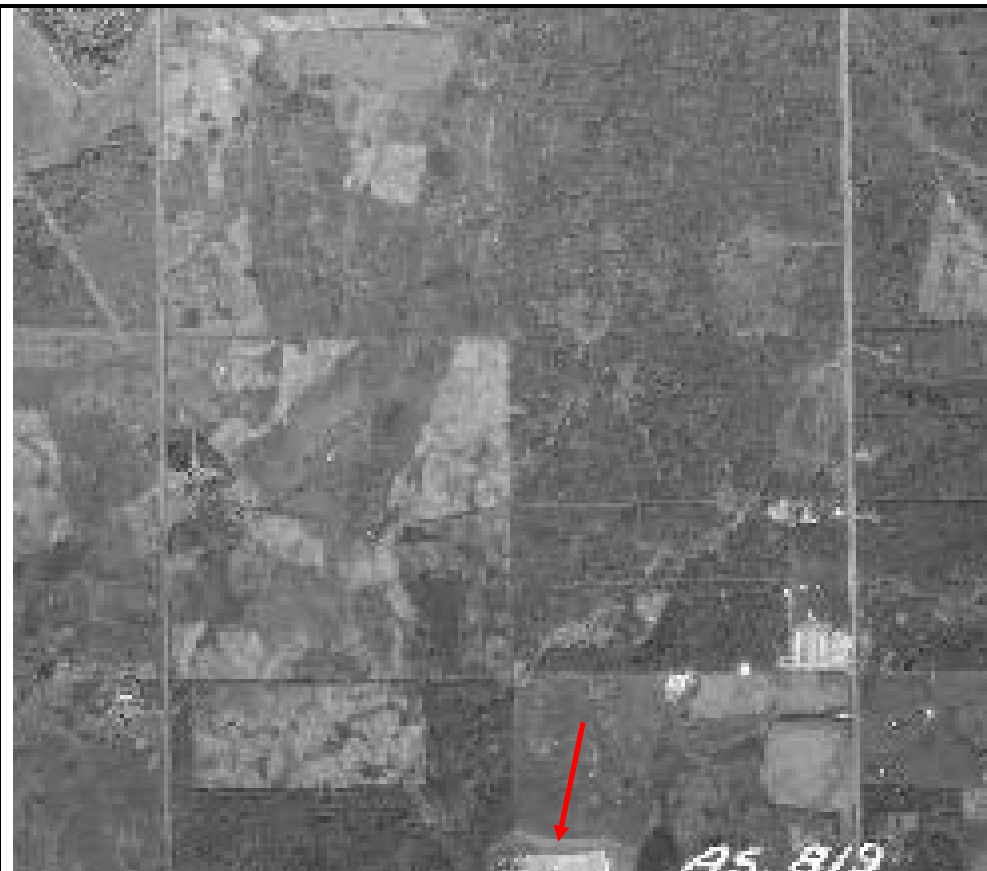
Historic Aerial: 30 and 19-51-22 W4M, May 26, 1962 (Image AS819). This image was taken approximately 18 years prior to the abandonment of Segment 1A.

KP 18.8 to KP 19.0: Shallow, open water wetland (no previous concerns identified). The pipeline ROW is visible to the left of the shallow, open water area and runs through the bottom left corner of the pond.

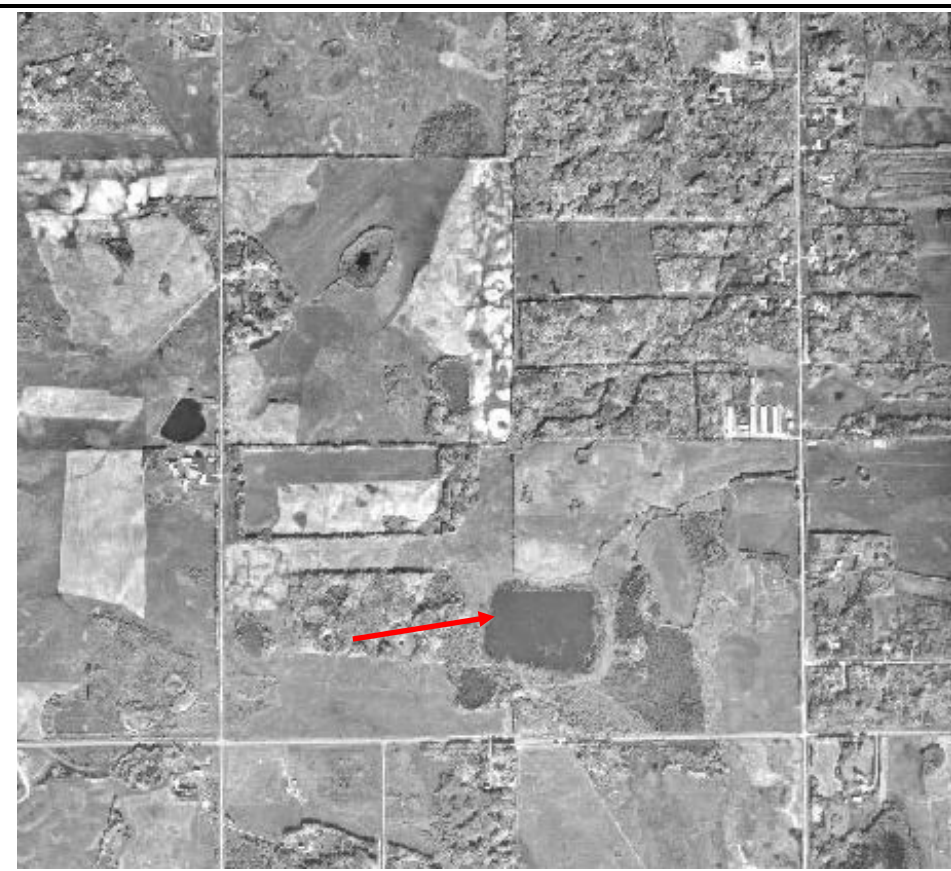
Historic Aerial: 17-51-22 W4M, September 26, 1976 (Image AS299). This image was taken approximately 4 years prior to the abandonment of Segment 1A.

KP 18.8 to KP 19.0: Shallow, open wetland (no previous concerns identified). The pipeline ROW runs through the bottom left corner of the pond; there does not appear to be evidence of an altered size of the pond.

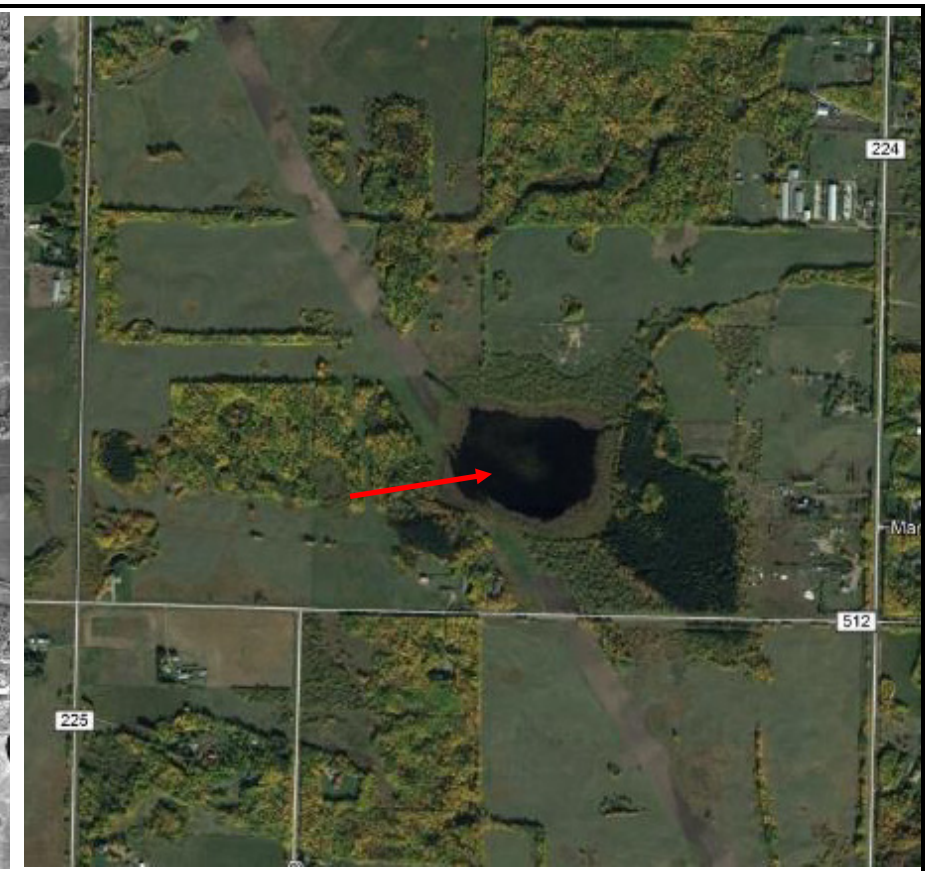
Photoplate: Aerial view of the shallow, open water wetland (Google Earth, September 29, 2018). This image was taken approximately 38 years after the abandonment of Segment 1A.

There is no evidence of alteration of the shape or size of the wetland.

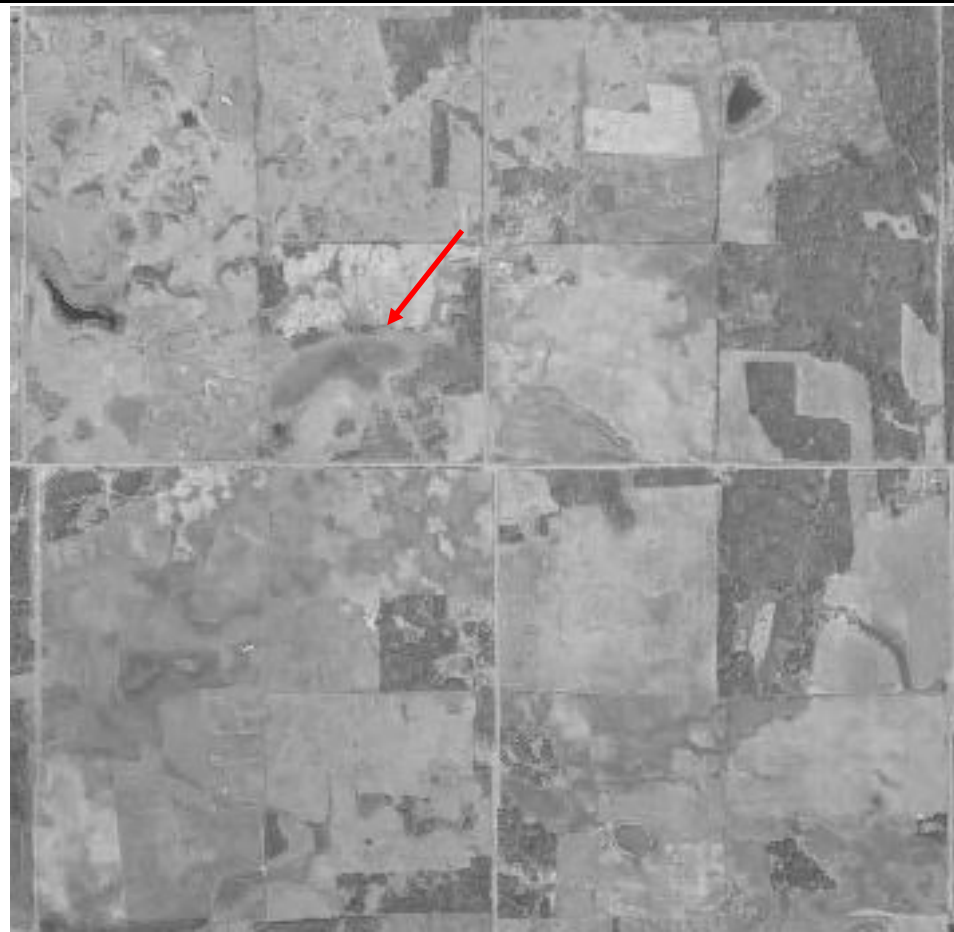
Historic Aerial: 4-51-22 W4M and 33-50-22 W4M, June 2, 1969 (Image AS1006). This image was taken approximately 11 years prior to the abandonment of Segment 1A.

KP 22.5 to KP 22.9: Seasonal marsh/shrubby swamp complex (no previous concerns identified).

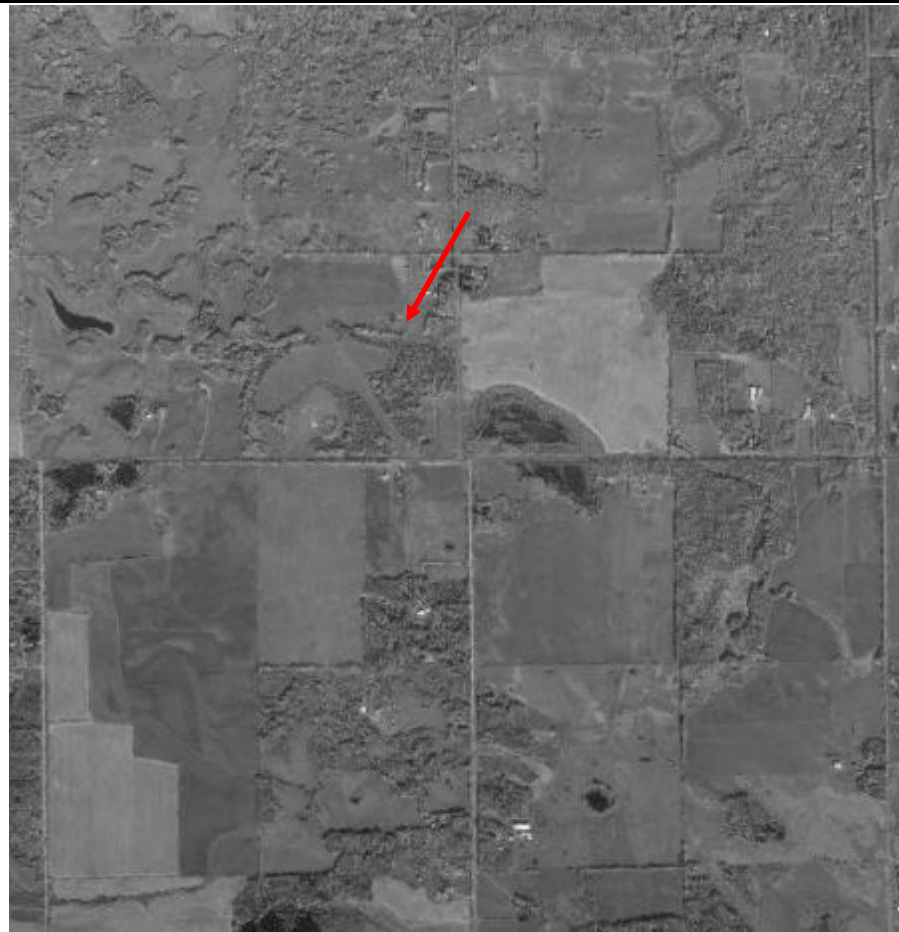
Historic Aerial: 4-51-22 W4M and 33-50-22 W4M, October 1, 2008 (Image AS5460B). This image was taken approximately 28 years after the abandonment of Segment 1A.

KP 22.5 to KP 22.9: Seasonal marsh/shrubby swamp complex (no previous concerns identified). The wetland is approximately the same shape and size as prior to pipeline abandonment.

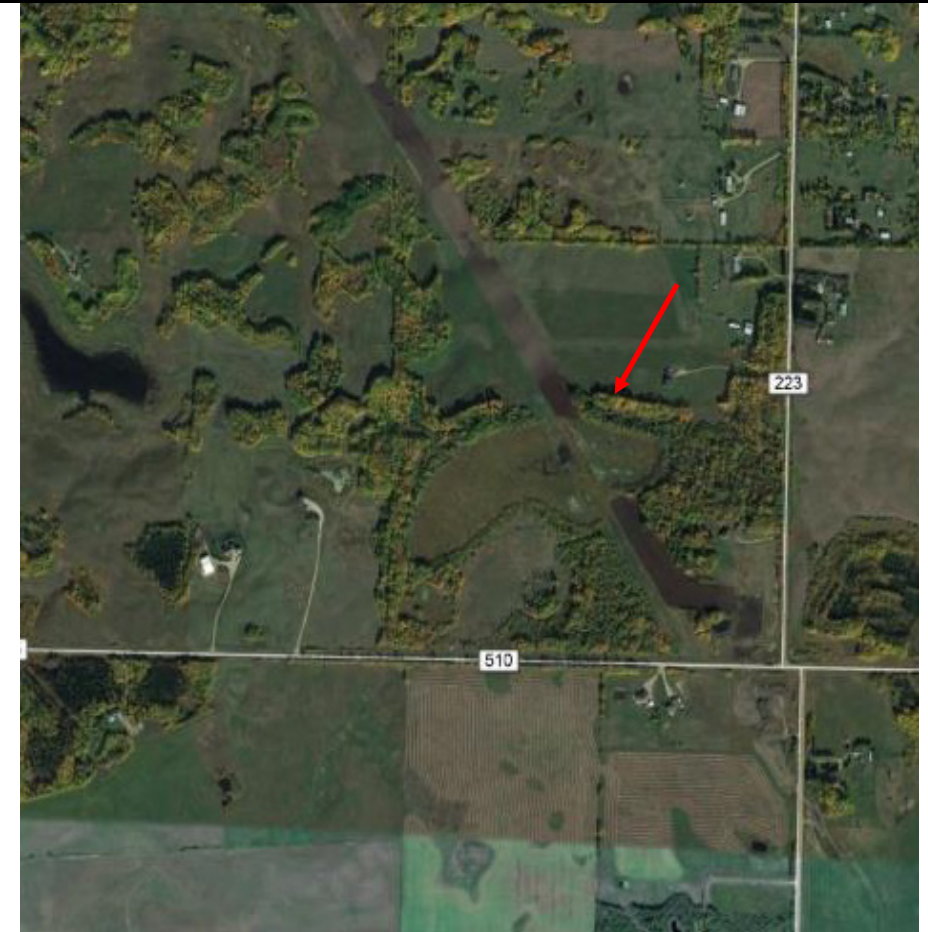
Photoplate: Aerial view of seasonal marsh/shrubby swamp complex (Google Earth, September 29, 2018). This image was taken approximately 38 years after the abandonment of Segment 1A.

There is no evidence of change of the shape or size of the seasonal marsh/shrubby swamp complex.

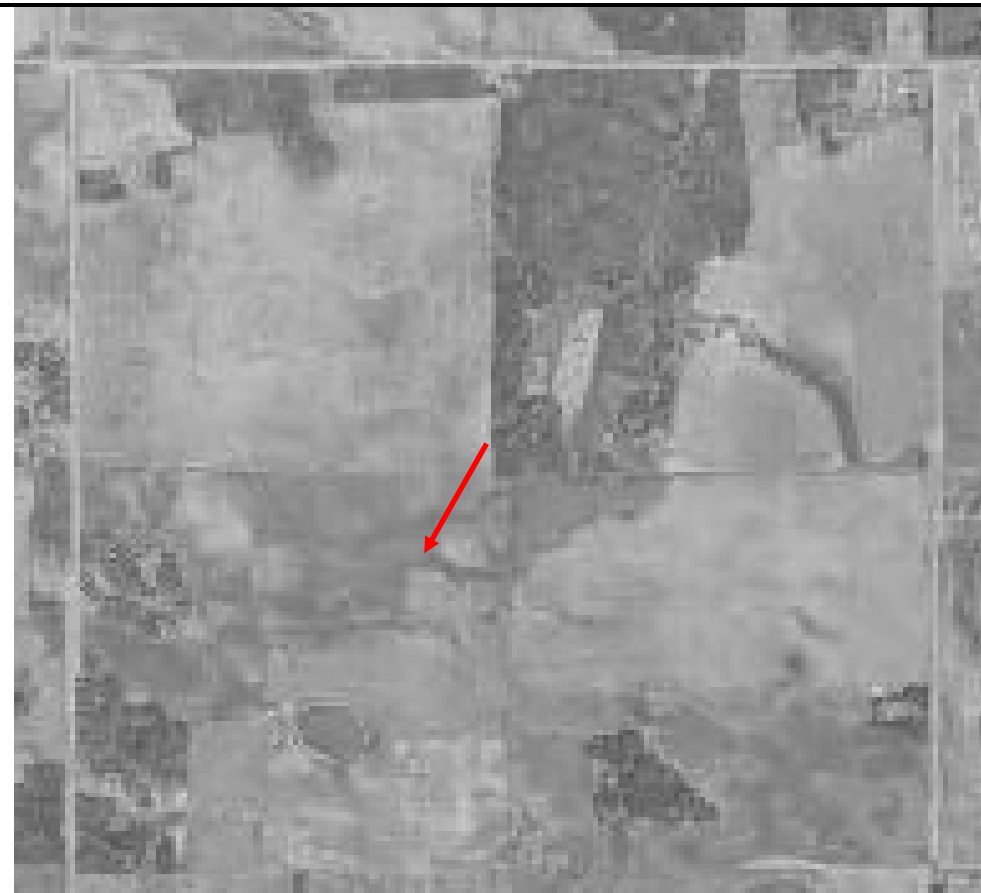
Historic Aerial: 4-51-22 W4M and 33-50-22 W4M, June 2, 1969 (Image AS1006). This image was taken approximately 11 years prior to the abandonment of Segment 1A.

KP 24.3 to KP 24.4: Watercourse – Irvine Creek. The image quality is poor, but the creek can be seen at the red arrow.

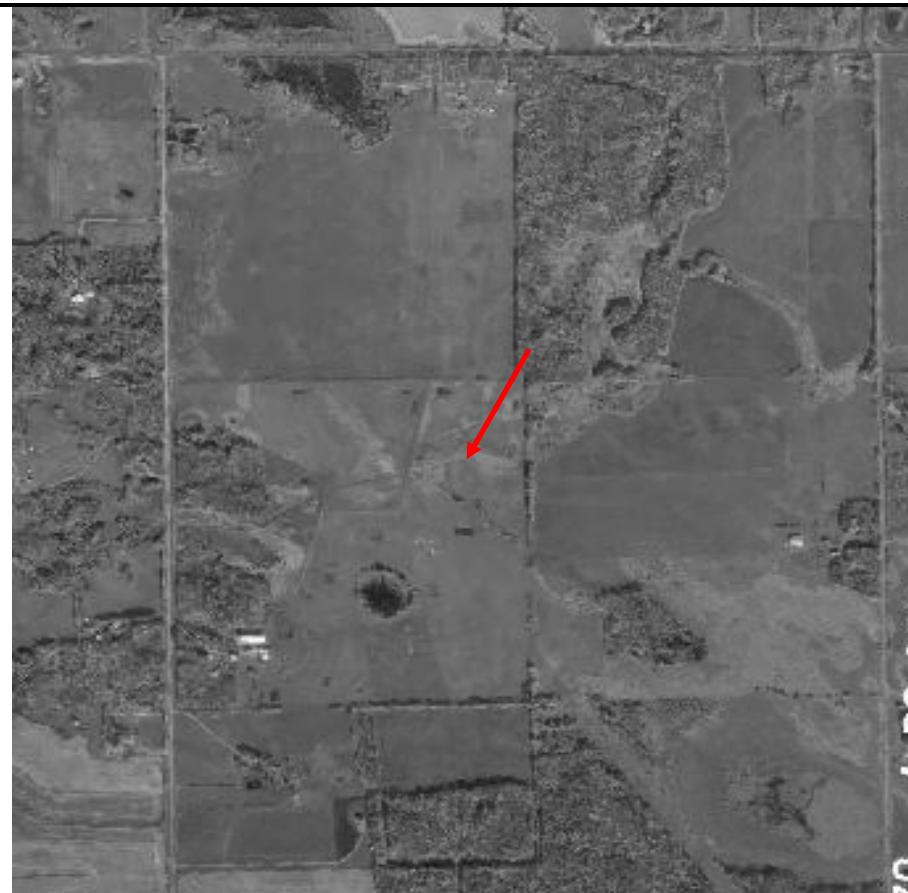
Historic Aerial: 4-51-22 W4M and 33-50-22 W4M, October 1, 2008 (Image AS5460B). This image was taken approximately 28 years after the abandonment of Segment 1A.

KP 24.3 to KP 24.4: Watercourse – Irvine Creek. There is no evidence of alternation of the trajectory of the creek.

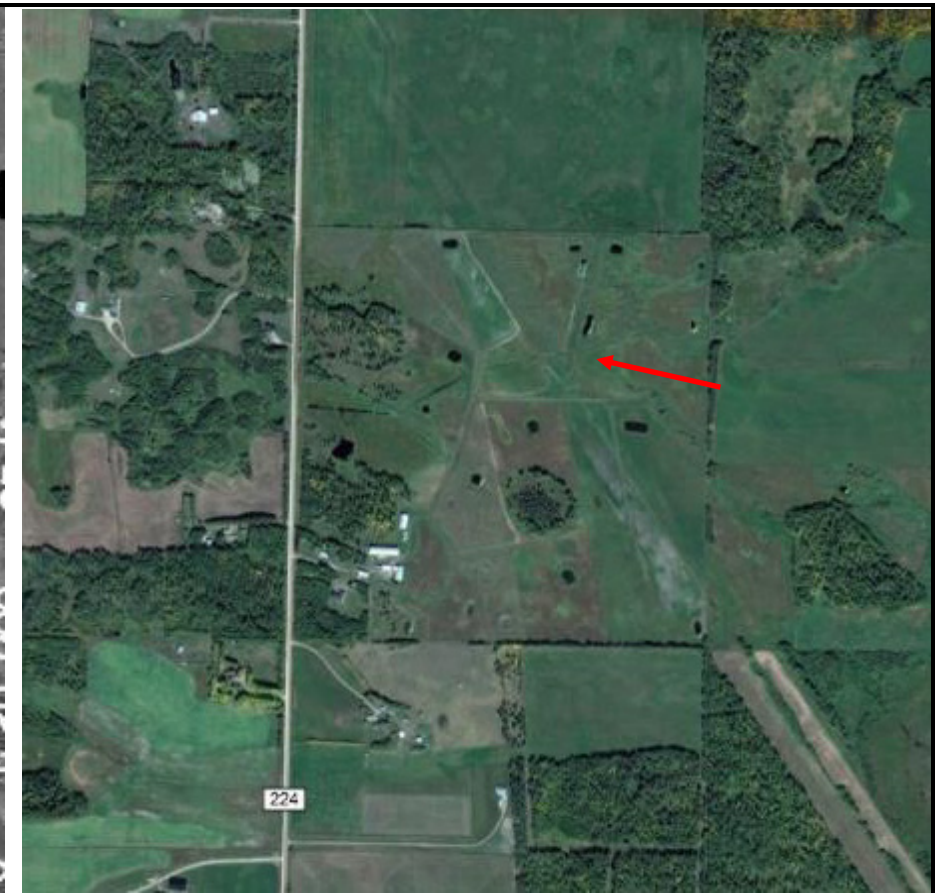
Photo-plate: Aerial view of Irvine Creek (Google Earth, September 29, 2018). This image was taken approximately 38 years after the abandonment of Segment 1A.

The creek runs through a property that is currently used to raise elk and, as such, the owner appears to have channelized Irvine Creek and created numerous dugouts on the property for watering his animals. Irvine Creek does not appear to have been altered as a result of the pipeline ROW.

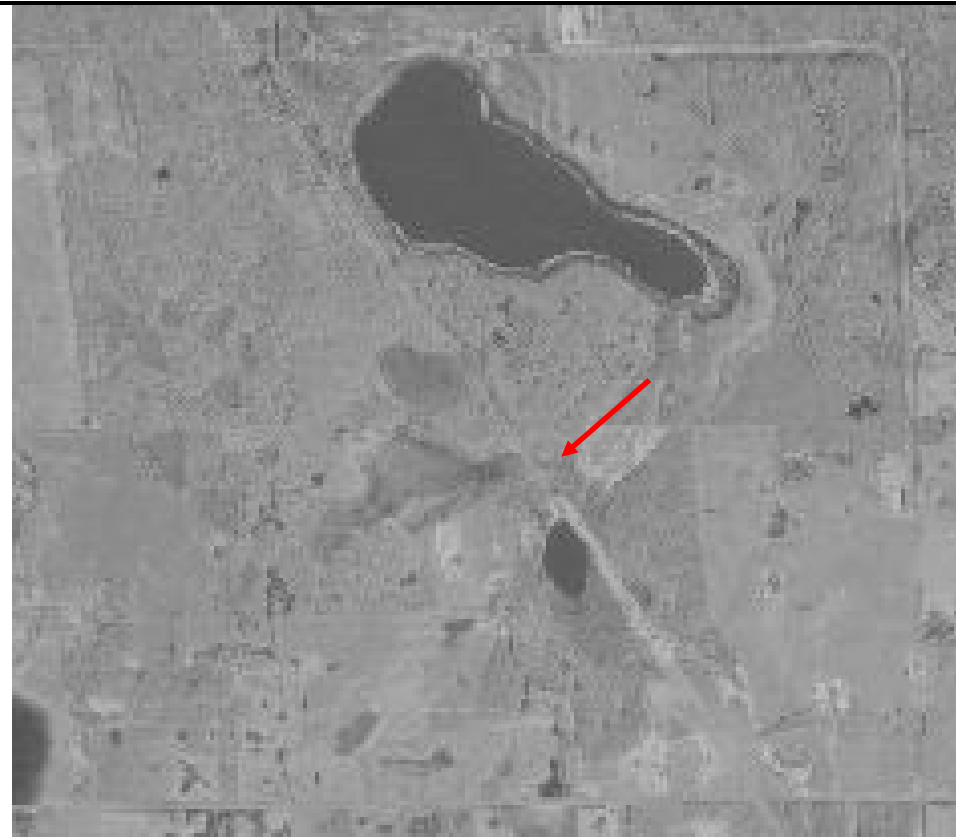
Historic Aerial: 27 and 22-50-22 W4M, August 5, 1962 (Image AS819). This image was taken approximately 18 years prior to the abandonment of Segment 1A.

KP 26.3 to KP 26.4: Gully erosion observed in 2016. The erosion was observed during the Post-construction Environmental Monitoring (PCEM) of another pipeline ROW within this corridor and cannot be conclusively attributed to the abandoned Segment 1A.

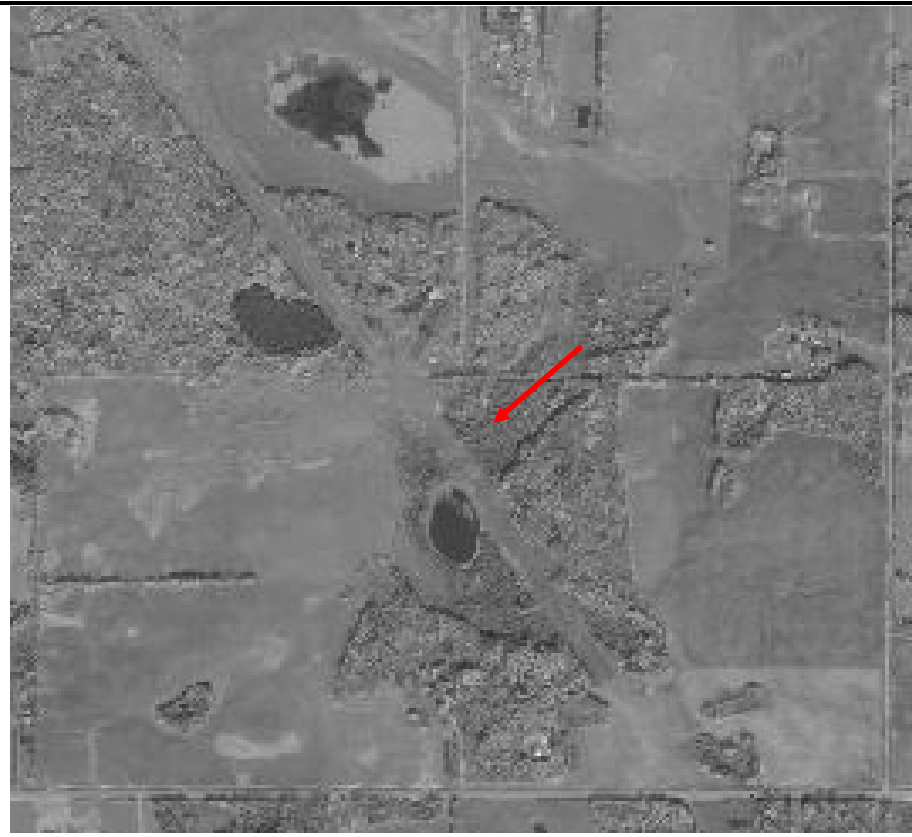
Historic Aerial: 27 and 22-50-22 W4M, October 1, 2008 (Image AS5460B). This image was taken approximately 28 years after the abandonment of Segment 1A.

KP 26.3 to KP 26.4: Gully erosion observed in 2016. The erosion was observed during the PCEM of another pipeline ROW within this corridor and cannot be conclusively attributed to the abandoned Segment 1A. The pipeline corridor is visibly wider than it was in 1962.

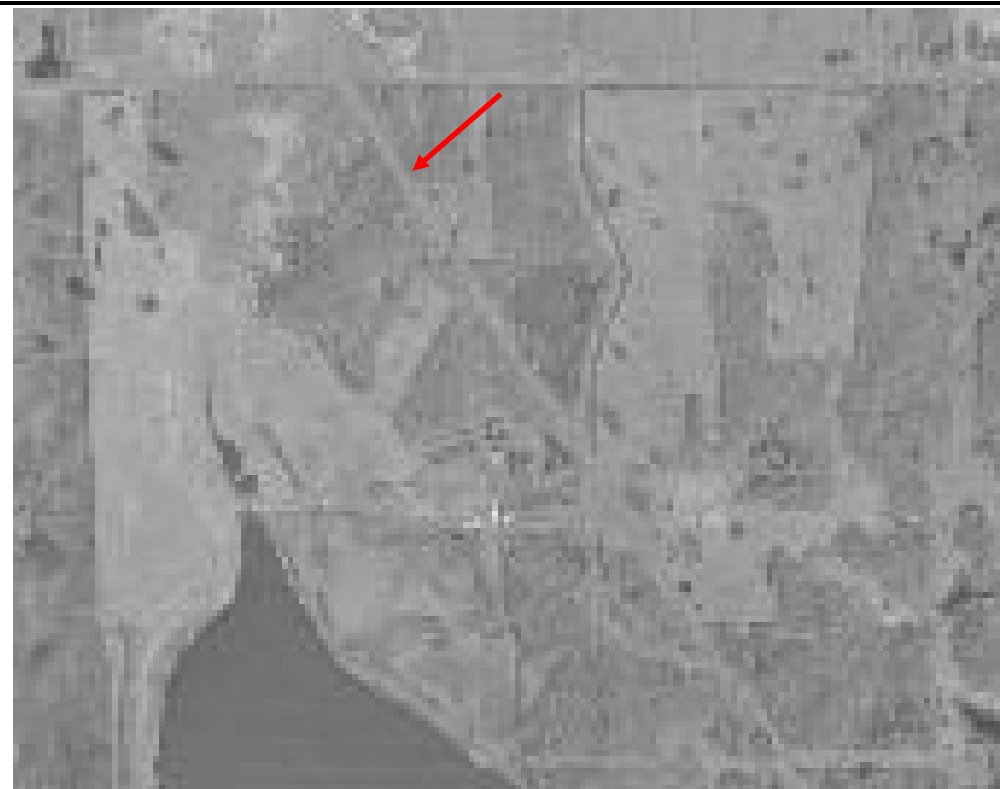
Historic Aerial: 27 and 22-50-22 W4M, August 5, 1962 (Image AS819). This image was taken approximately 18 years prior to the abandonment of Segment 1A.

KP 27.1 to KP 27.5: Temporary marshes and treed area (weed issue observed in 2016, willow and success species recovery noted in 2017). The weed issue was noted during the PCEM of another pipeline ROW in the corridor and is an incidental finding for this Project.
