FINAL REPORT

Review of Previous Pipeline Abandonment Program – Phase 3 Abandonment on Farmland

Pipeline Abandonment
Research Steering
Committee

February 2019

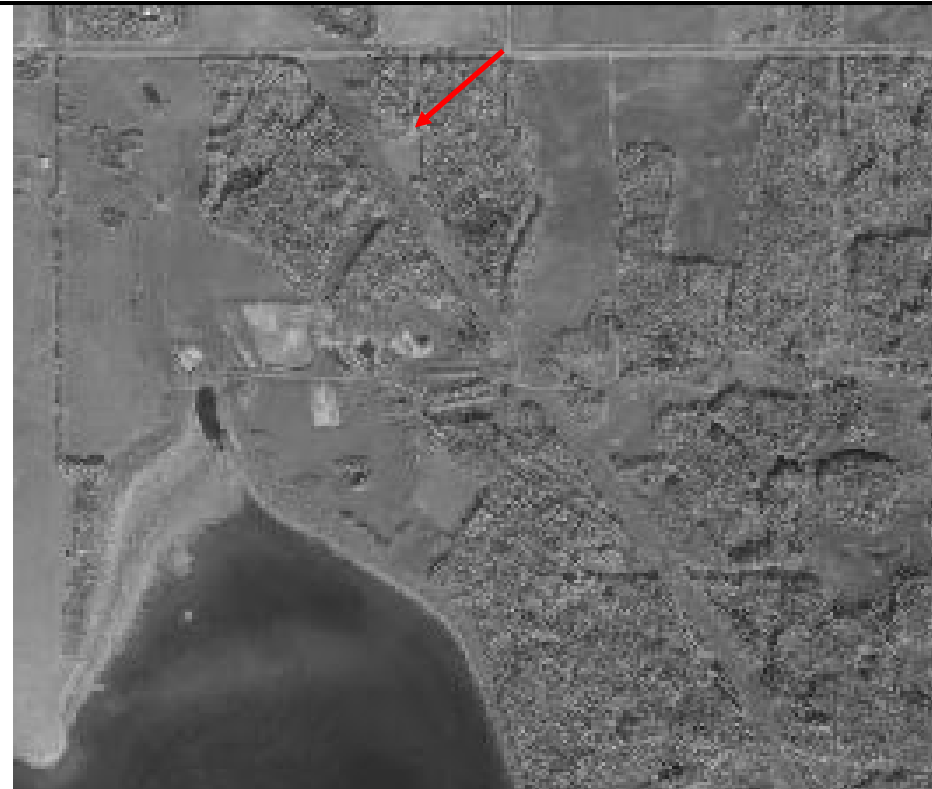
Historic Aerial: 27 and 22-50-22 W4M, October 1, 2008 (Image AS5460B). This image was taken approximately 28 years after the abandonment of Segment 1A.

KP 27.1 to KP 27.5: Temporary marshes and treed area (weed issue observed in 2016, willow and success species recovery noted in 2017). The pipeline corridor is visibly wider than in 1962. There is no evidence of altered size or shape of the temporary marshes.

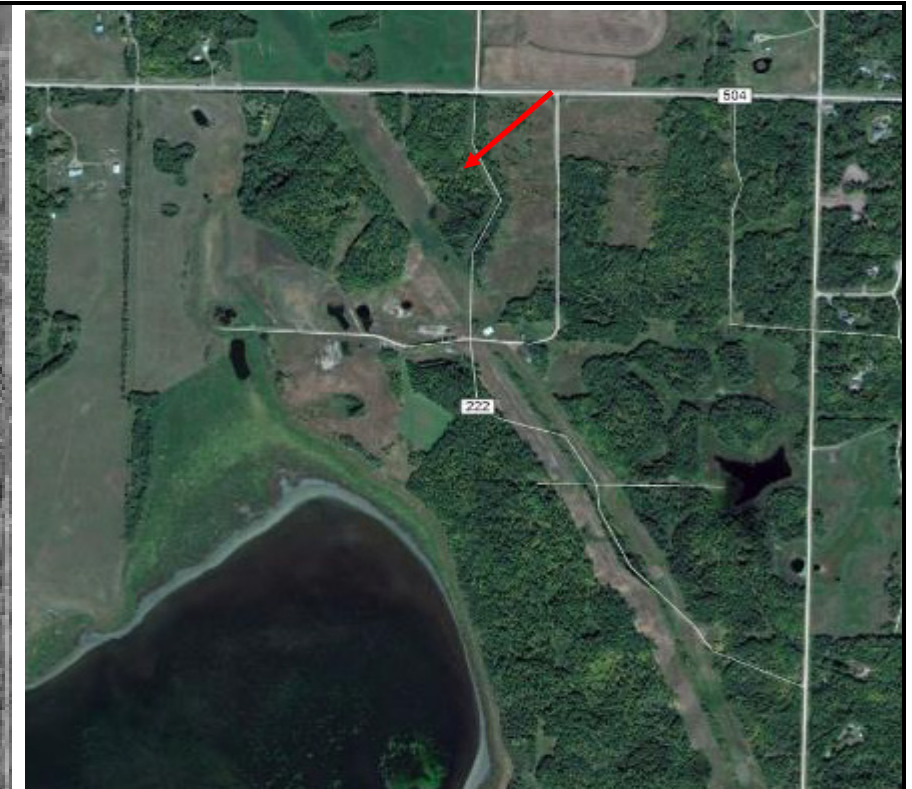
Photoplate: Aerial view of temporary marshes and treed area (Google Earth, September 29, 2018). This image was taken approximately 38 years after the abandonment of Segment 1A.

There is no evidence of altered size or shape of the temporary marshes.

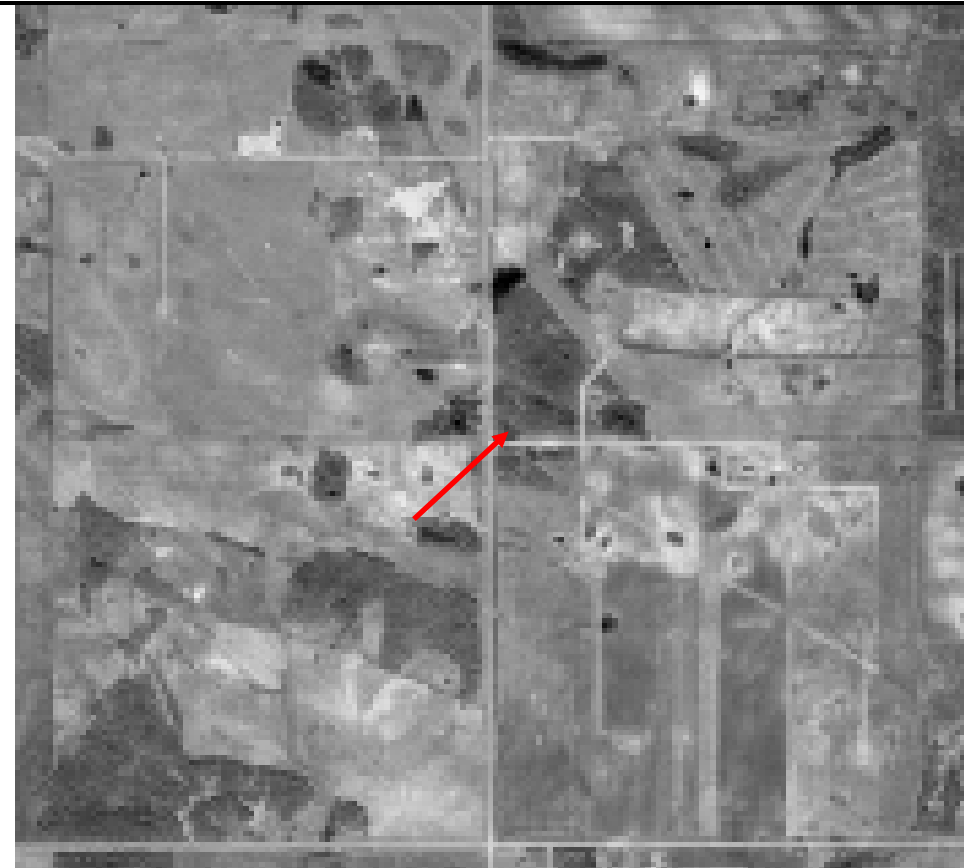
Historic Aerial: 30 and 29-49-22 W4M, May 26, 1962 (Image AS820). This image was taken approximately 18 years prior to the abandonment of Segment 1A.

KP 38.0 to KP 38.2: Shrubby swamps (no previous concerns identified) and road crossing.

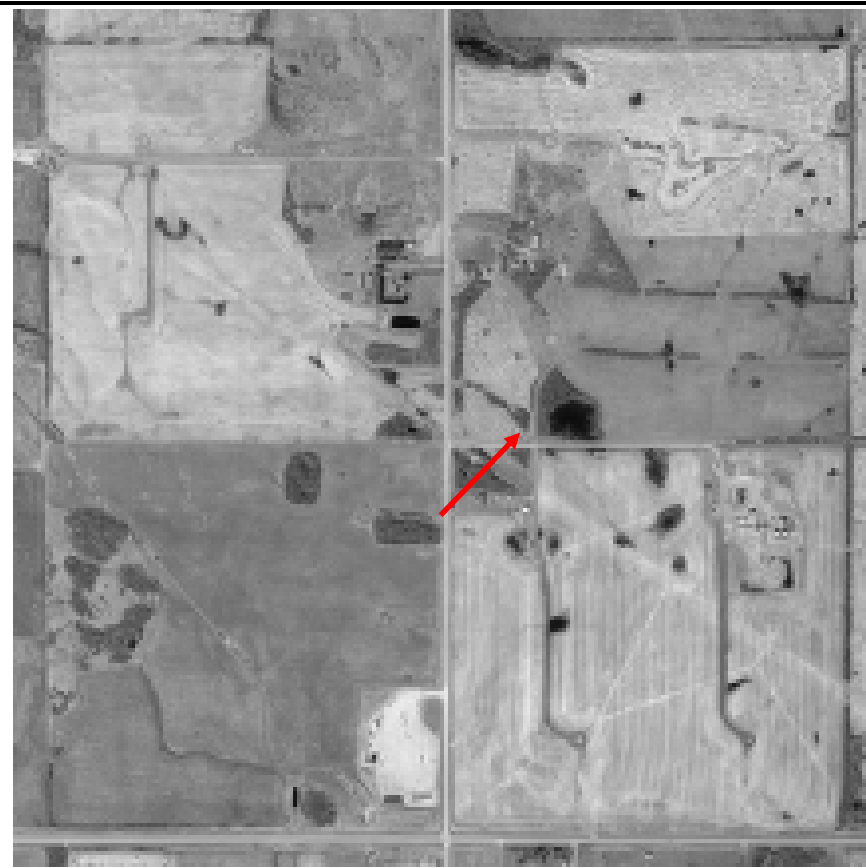
Historic Aerial: 30 and 29-49-22 W4M, 2011 (Image ERJ0183H). This image was taken approximately 21 years after the abandonment of Segment 1A.

KP 38.0 to KP 38.2: Shrubby swamps (no previous concerns identified) and road crossing. The pipeline corridor is visibly wider than in 1962.

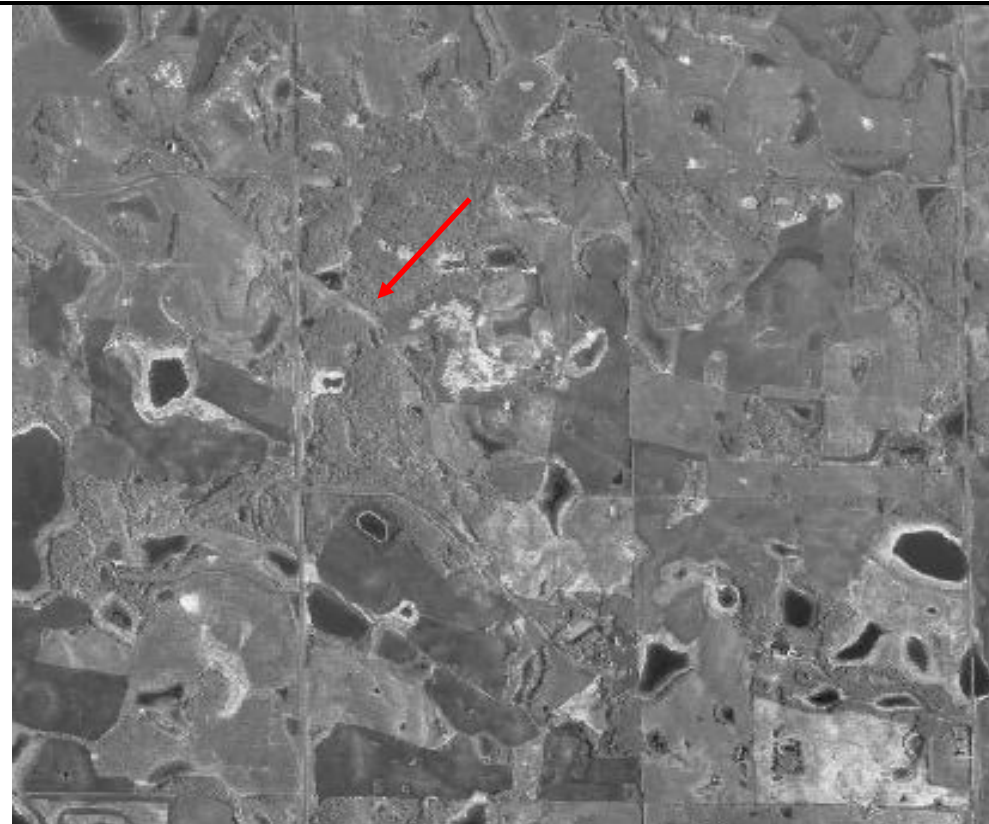
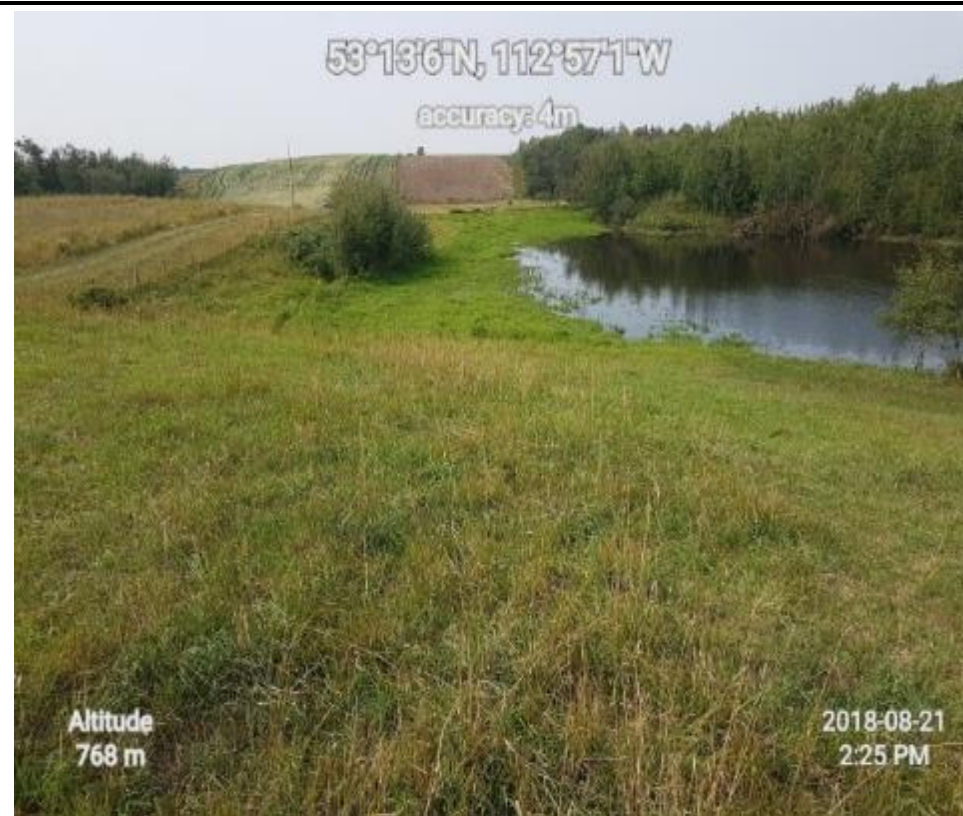
Historic Aerial: 12-49-21 W4M, May 26, 1962 (Image AS820). This image was taken approximately 18 years prior to the abandonment of Segment 1A.

KP 46.2 to KP 46.6: Temporary marsh and treed area (no previous concerns identified).

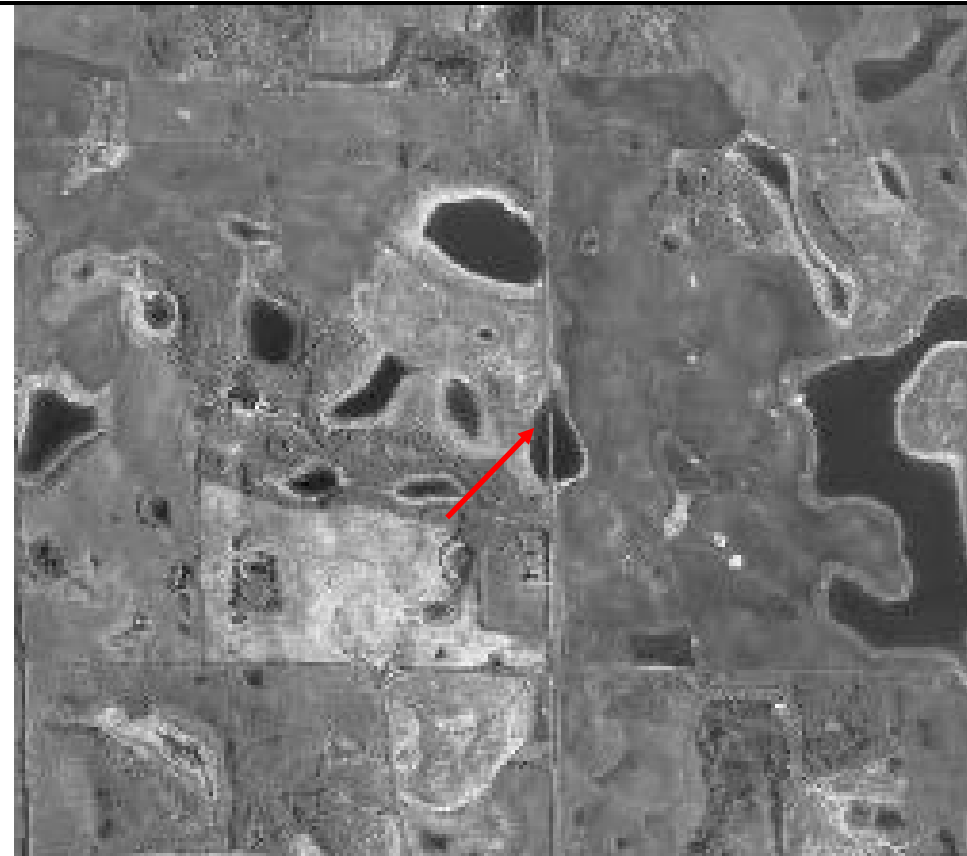
Historic Aerial: 12-49-21 W4M, May 26, 1962 (Image AS820). This image was taken approximately 18 years before the abandonment of Segment 1A.

KP 47.8 to KP 48.4: Subsidence and crop growth issue observed in 2016. The subsidence and crop growth issues were observed during the PCEM of another ROW within the corridor and cannot be conclusively attributed to the abandoned pipeline segment.

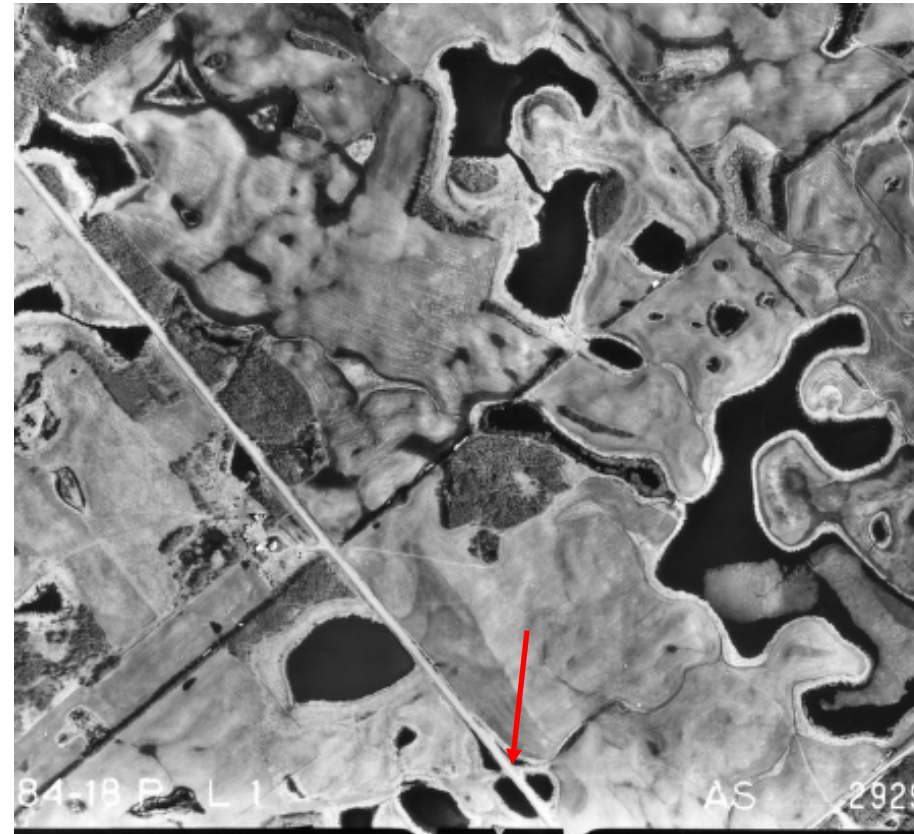
Historic Aerial: 12-49-21 W4M, April 12, 1984 (Image AS2929). This image was taken approximately 4 years after the abandonment of Segment 1A.

KP 47.8 to KP 48.4: Subsidence and crop growth issue observed in 2016. The pipeline corridor is visibly wider than in 1962.

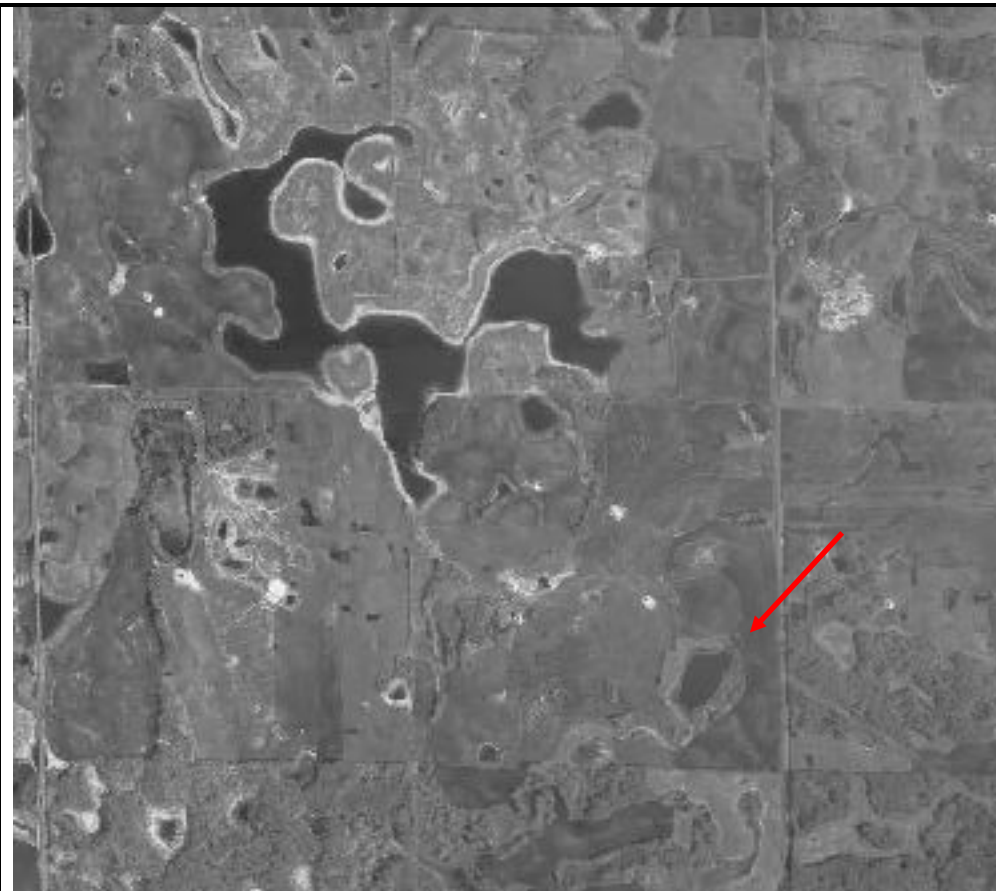
Historic Aerial: 12-49-21 W4M, May 26, 1962 (Image AS820). This image was taken approximately 18 years prior to the abandonment of Segment 1A.

KP 49.4 to KP 49.6: Semipermanent marsh (no previous concerns identified).

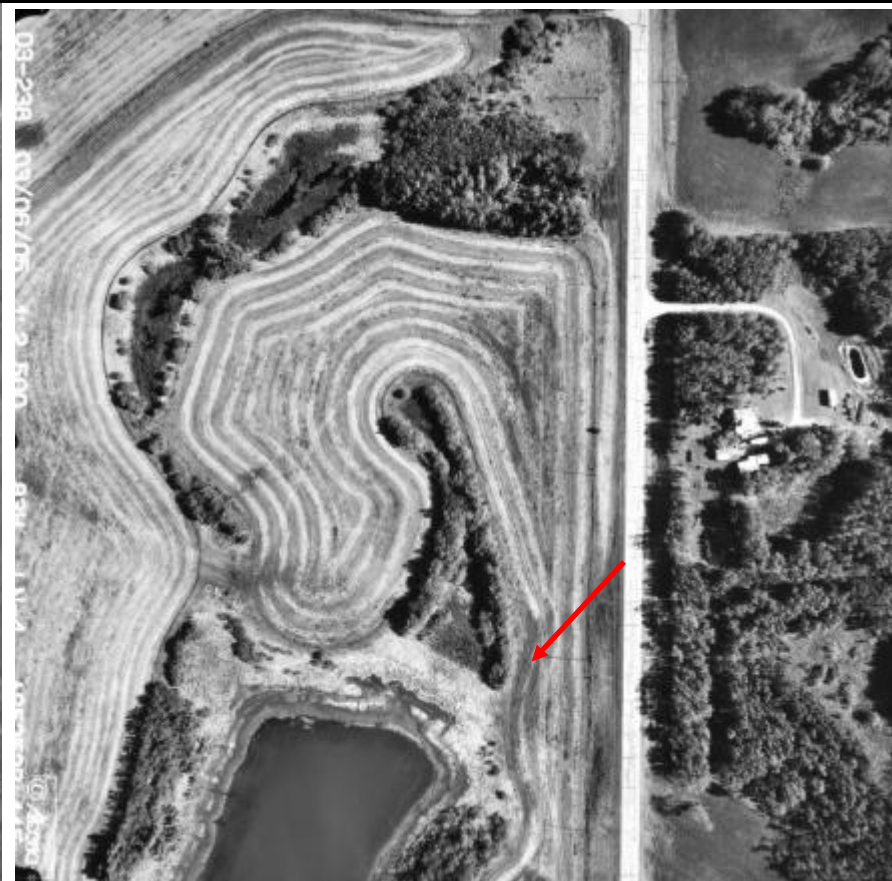
Historic Aerial: 6-49-20 W4M, June 5, 2003 (Image AS5252). This image was taken approximately 23 years after the abandonment of Segment 1A.

KP 49.4 to KP 49.6: Semipermanent marsh (no previous concerns identified). The pipeline corridor is visibly wider than in 1962, and there is no evidence of alteration of the shape or size of the semipermanent marsh.

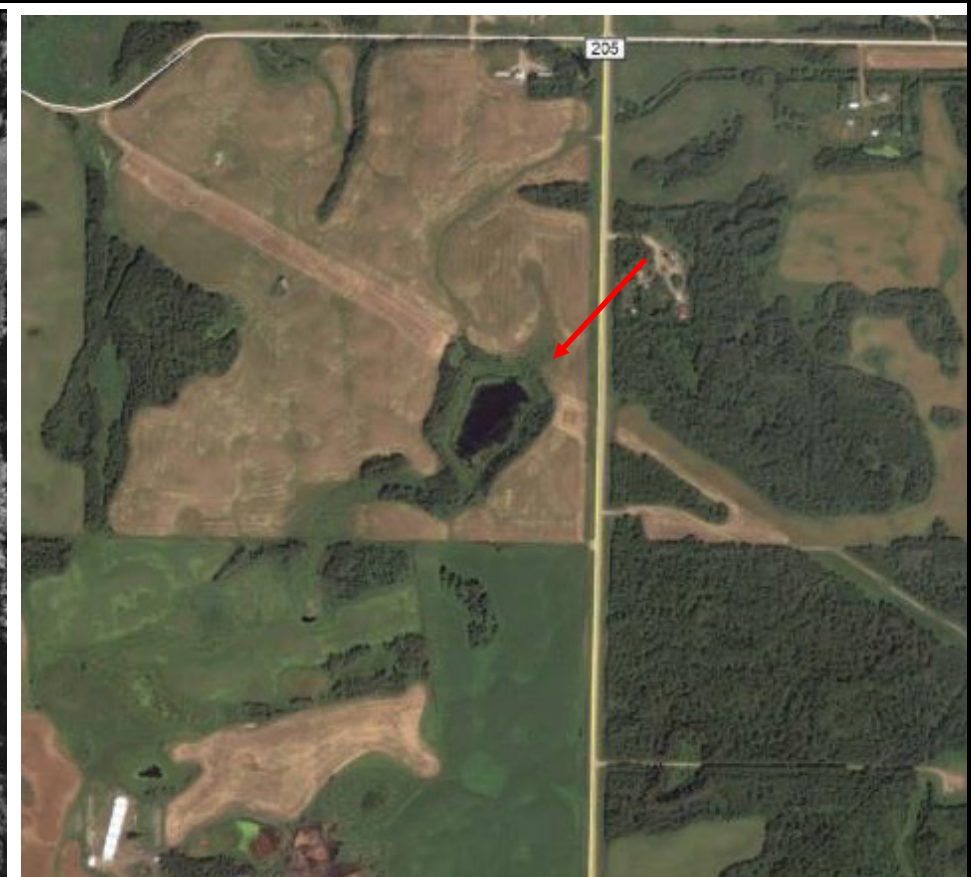
Photo-plate: Aerial view of semipermanent marsh (Google Earth, September 29, 2018). This image was taken approximately 38 years after the abandonment of Segment 1A.

There is no evidence of alteration of the shape or size of the semipermanent marsh.

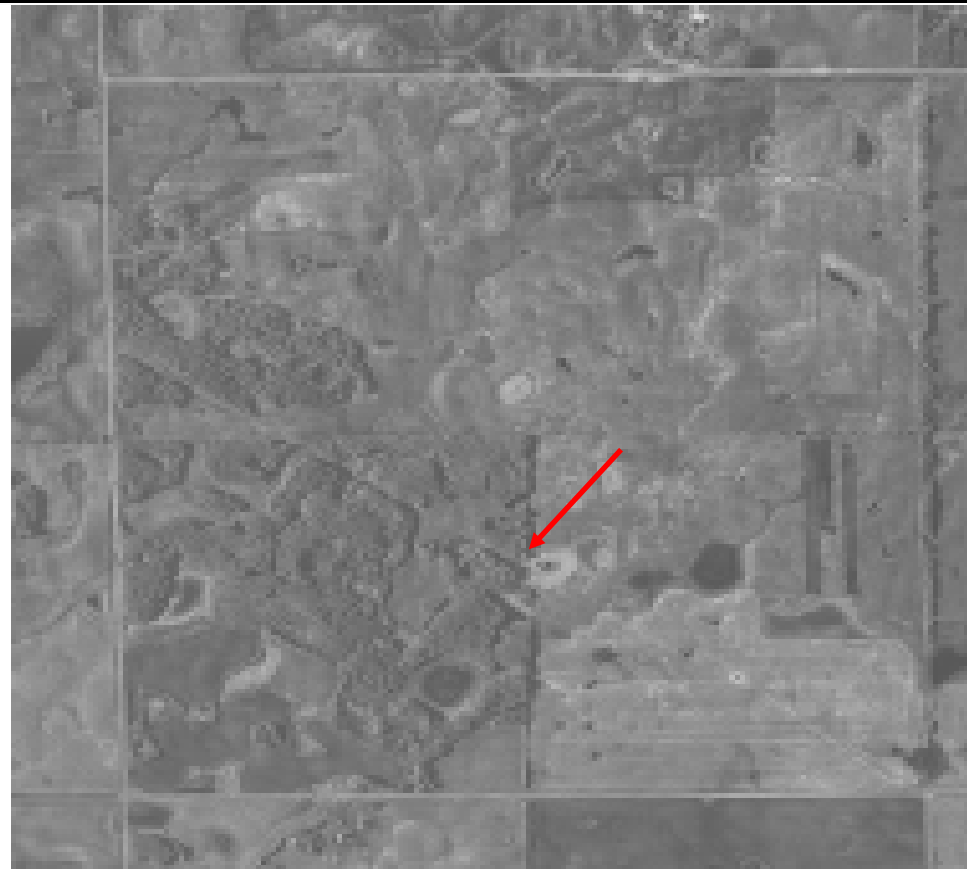
Historic Aerial: 6-49-20 W4M, May 26, 1962 (Image AS820). This image was taken approximately 12 years prior to the abandonment of Segment 1A and 6 years prior to the completion of the corrosion inspection and repair work.

KP 50.6 to KP 51.1: 1968 corrosion inspection/repair.

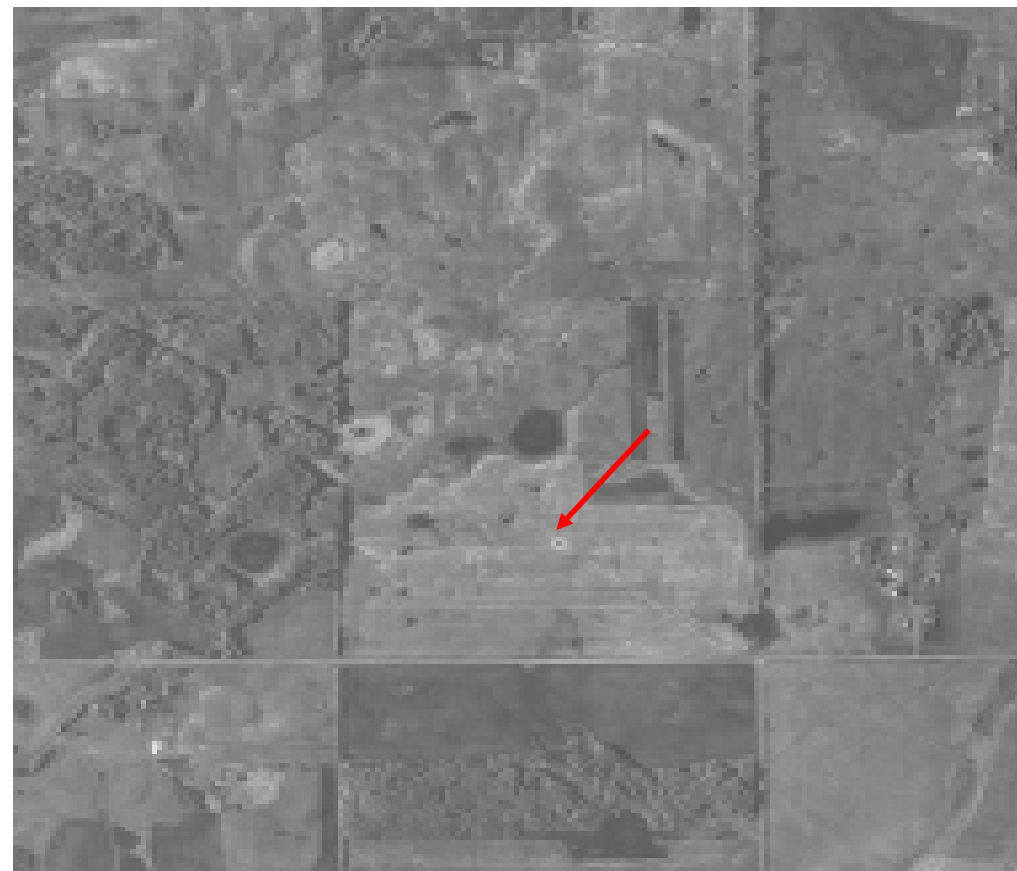
Historic Aerial: 6-49-20 W4M, May 26, 1962 (Image AS820). This image was taken approximately 18 years prior to the abandonment of Segment 1A.

KP 51.1: End Point of Segment 1A.

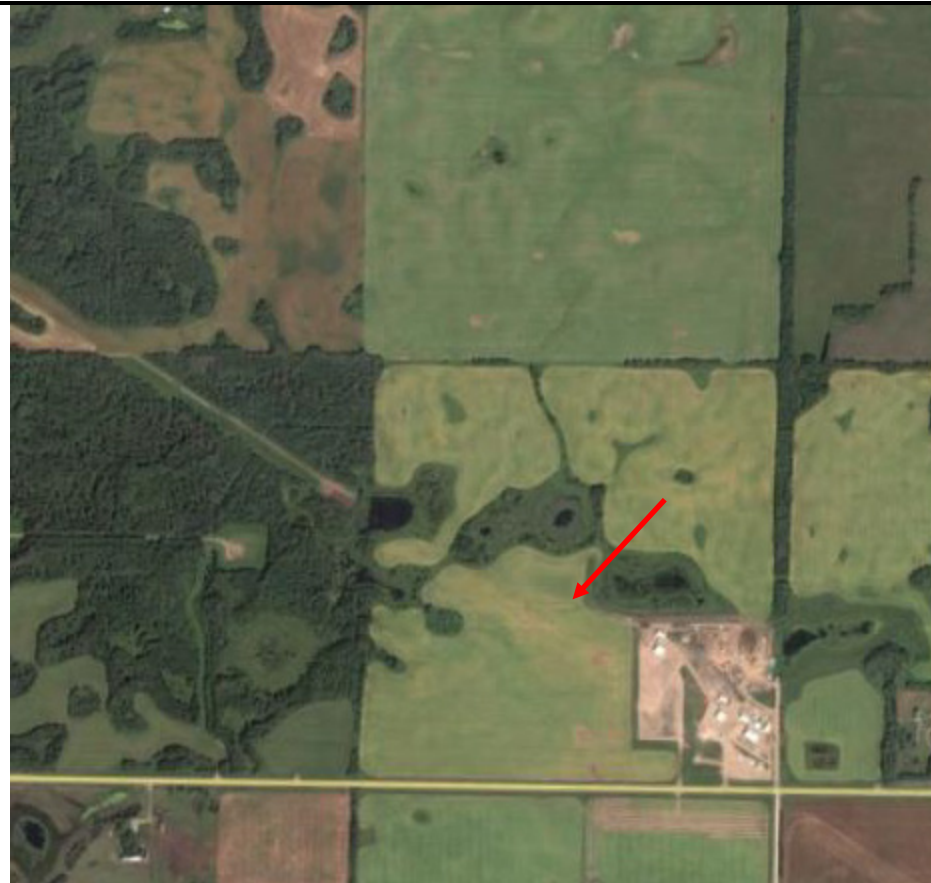
Photoplate: Aerial view of end point of Segment 1A (Google Earth, September 29, 2018). This image was taken approximately 38 years after the abandonment of Segment 1A.

There does not appear to be any issues associated with the cutting and capping activities that took place at this location.

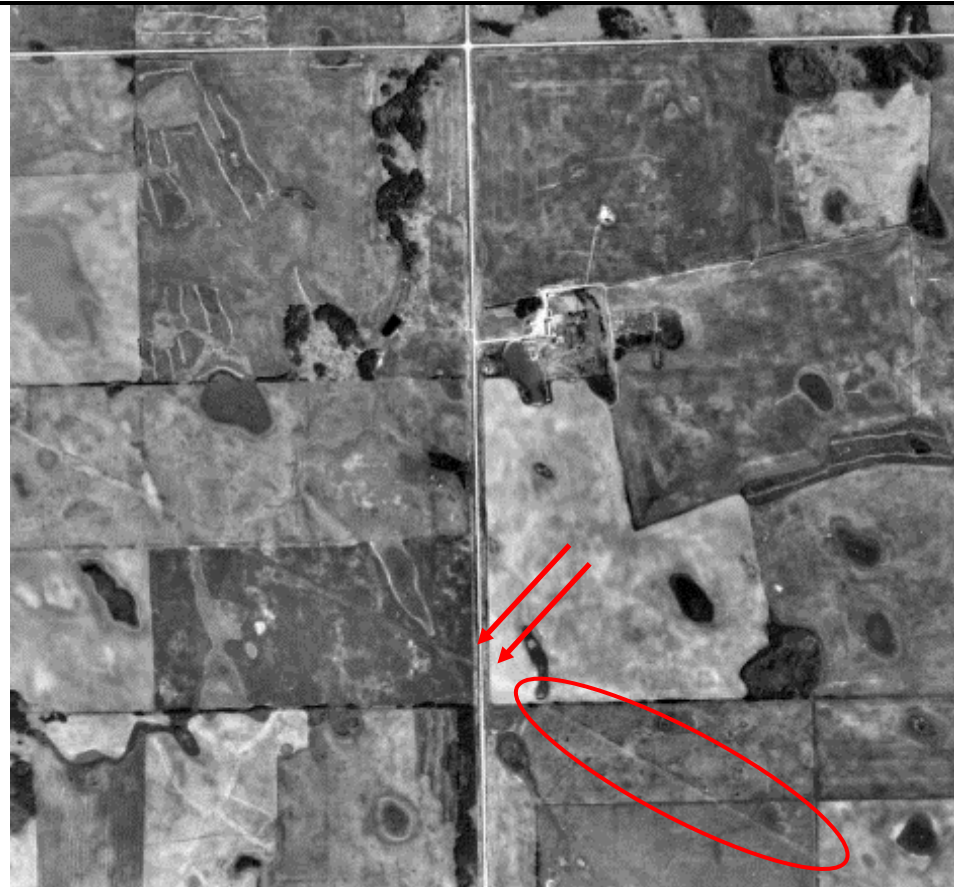
Historic Aerial: 36-45-15 W4M, July 7, 1975 (Image AS1386). This image was taken approximately 5 years prior to the abandonment of Segment 1B.

KP 116.0: Start point of Segment 1B.

KP 116.1: Cathodic protection (ground bed location identified on as-builts) and road crossing.

KP 116.1 to KP 117.1: Subsidence issue observed in 2016, approximately 41 years after the abandonment of Segment 1B. This issue was noted during the PCEM of another pipeline ROW within the corridor and is likely unrelated to the abandonment of Segment 1B.

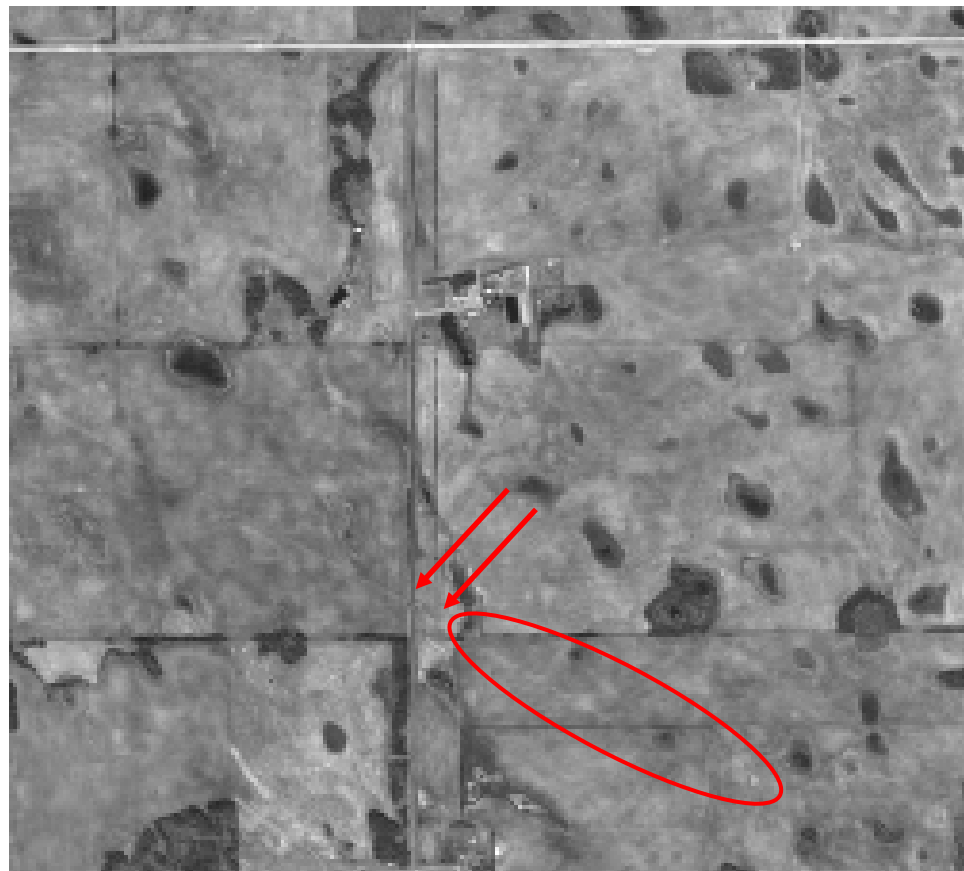
Photoplate: 36-45-15 W4M, June 3, 1993 (Image AS4398). This image was taken approximately 13 years after the abandonment of Segment 1B.

KP 116.0: Start point of Segment 1B.

KP 116.1: Cathodic protection (ground bed location identified on as-builts) and road crossing.

KP 116.1 to KP 117.1: Subsidence issue observed in 2016, approximately 13 years after the abandonment of Segment 1B. This issue was noted during the PCEM of another pipeline ROW within the corridor and is likely unrelated to the abandonment of Segment 1B.

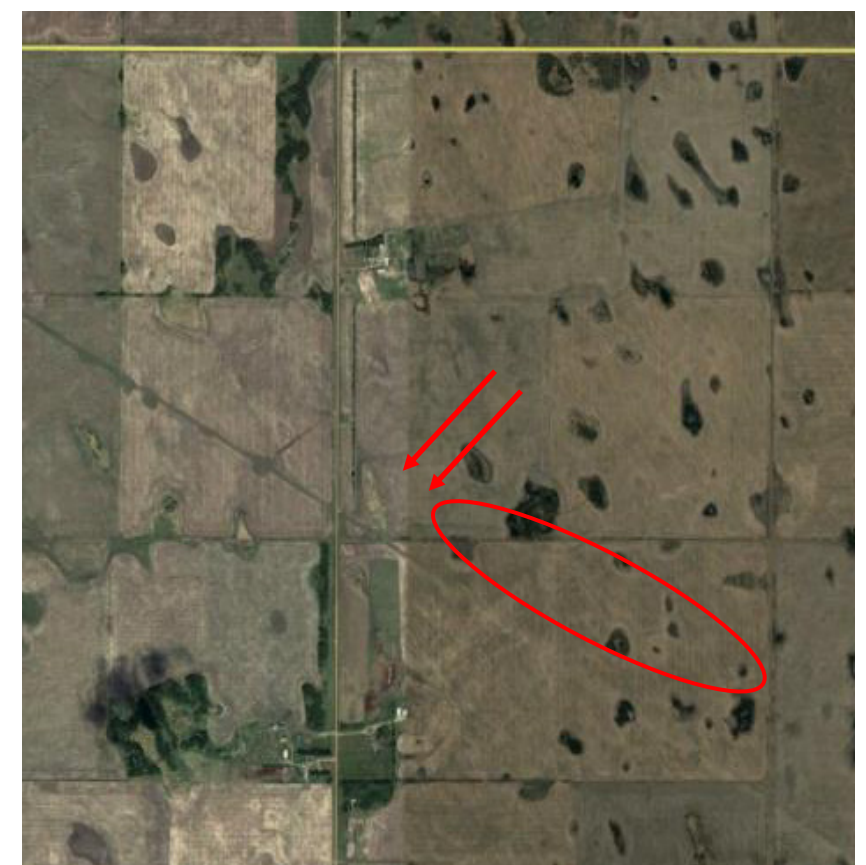
Photoplate: Aerial view of end point of Segment 1A, cathodic protection area, road crossing, and subsidence area (Google Earth, September 29, 2018). This image was taken approximately 38 years after the abandonment of Segment 1B.

The subsidence mitigation was most likely applied to the entire pipeline corridor and, as such, even if there was subsidence associated with Segment 1B, it would not have been observed in 2018.

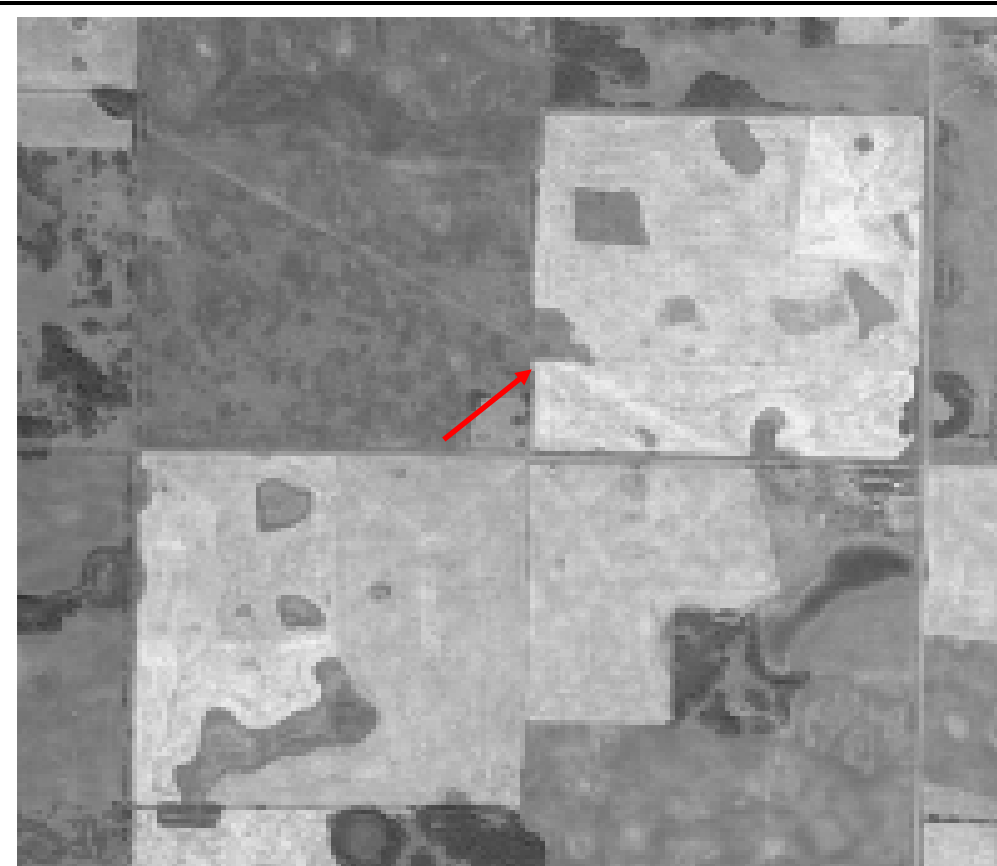
Historic Aerial: 22-45-14 W4M, September 19, 1967 (Image AS981). This image was taken approximately 13 years prior to the abandonment of Segment 1B.

KP 118.9 to KP 119.4: Subsidence issue observed and repaired in 2016, and road crossing. This issue was noted during the PCEM of another pipeline ROW within the corridor and is likely unrelated to the abandonment of Segment 1B.

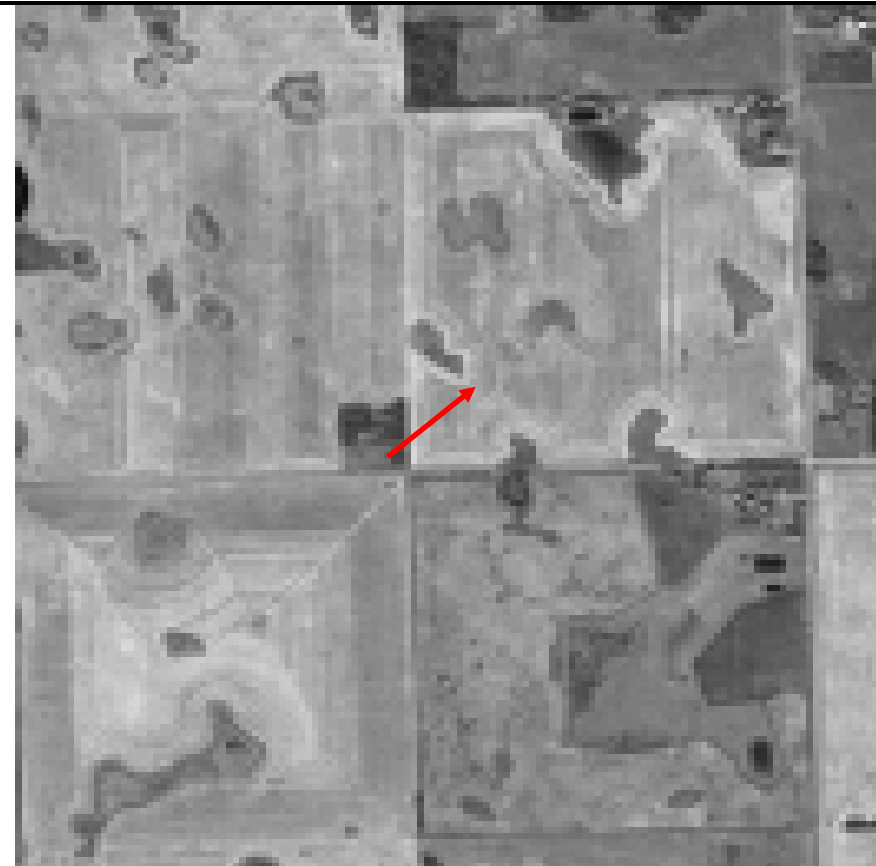
Historic Aerial: 22-45-14 W4M, May 10, 2005 (Image AS5326). This image was taken approximately 11 years prior to the abandonment of Segment 1B.

KP 118.9 to KP 119.4: Subsidence issue observed and repaired in 2016, and road crossing. This issue was noted during the PCEM of another pipeline ROW within the corridor and is likely unrelated to the abandonment of Segment 1B.

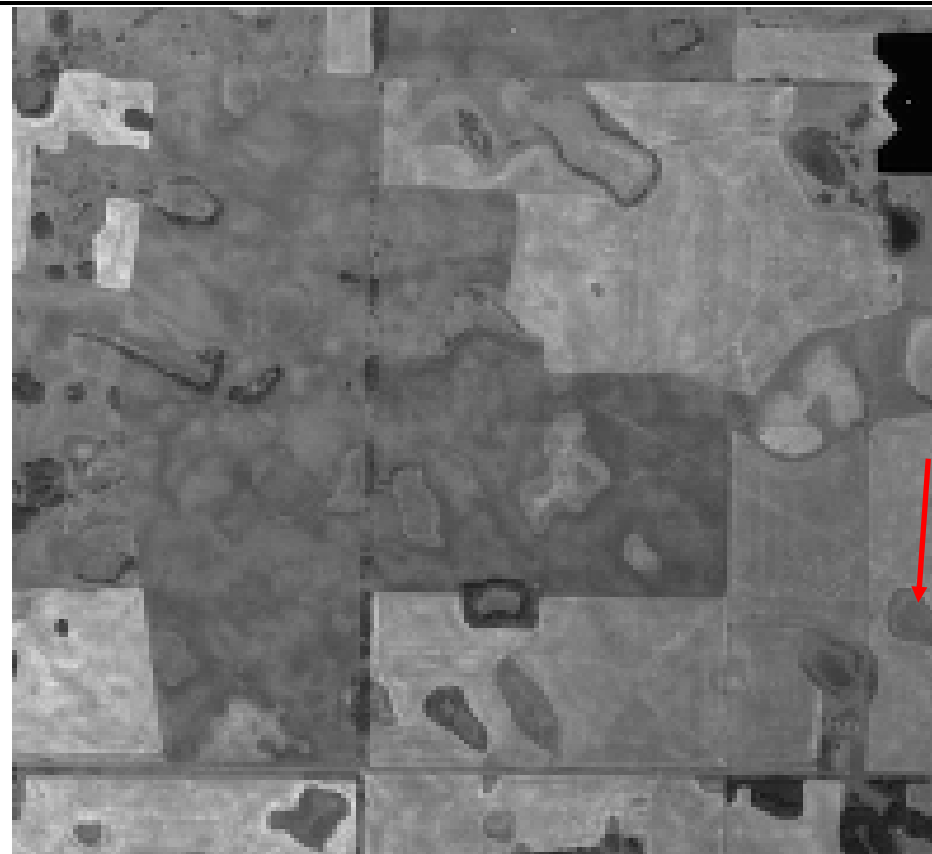
Historic Aerial: 22-45-14 W4M, September 19, 1967 (Image AS981). This image was taken approximately 13 years prior to the abandonment of Segment 1B.

KP 124.9 to KP 125.4: Seasonal marsh (no previous concerns identified) and subsidence issue observed in 2016. This issue was noted during the PCEM of another pipeline ROW within the corridor and is likely unrelated to the abandonment of Segment 1B.

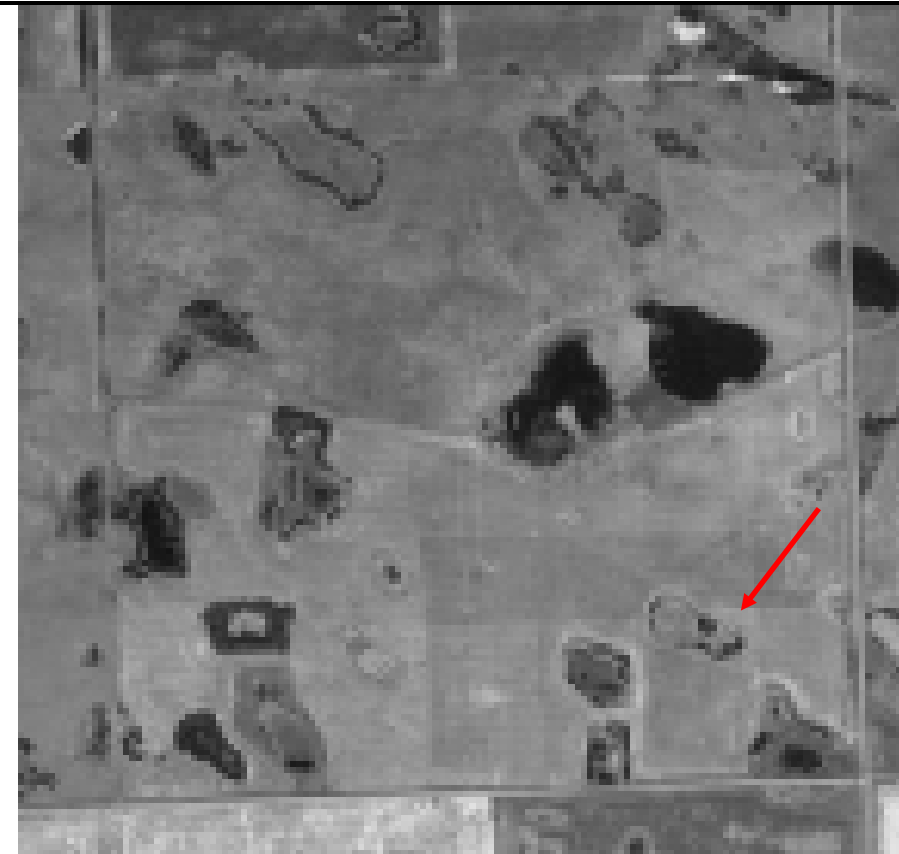
Historic Aerial: 22-45-14 W4M, May 10, 2005 (Image AS5326). This image was taken approximately 25 years after the abandonment of Segment 1B.

KP 124.9 to KP 125.4: Seasonal marsh (no previous concerns identified) and subsidence issue observed in 2016. This issue was noted during the PCEM of another pipeline ROW within the corridor and is likely unrelated to the abandonment of Segment 1B.

There is no evidence of change in the size or shape of the seasonal marsh.

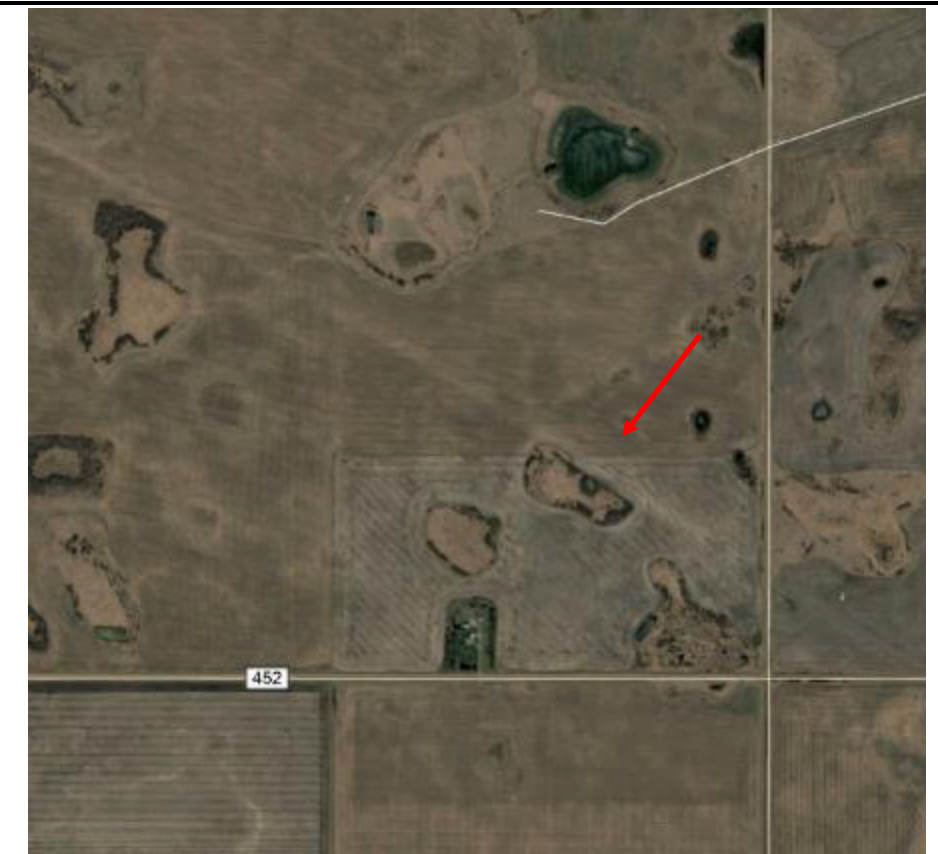
Photoplate: Aerial view of seasonal marsh (Google Earth, September 29, 2018).

The subsidence mitigation was most likely applied to the entire pipeline corridor and, as such, even if there was subsidence associated with Segment 1B, it could not be conclusively attributed to the abandoned ROW.

There is no evidence of change in the size or shape of the seasonal marsh.

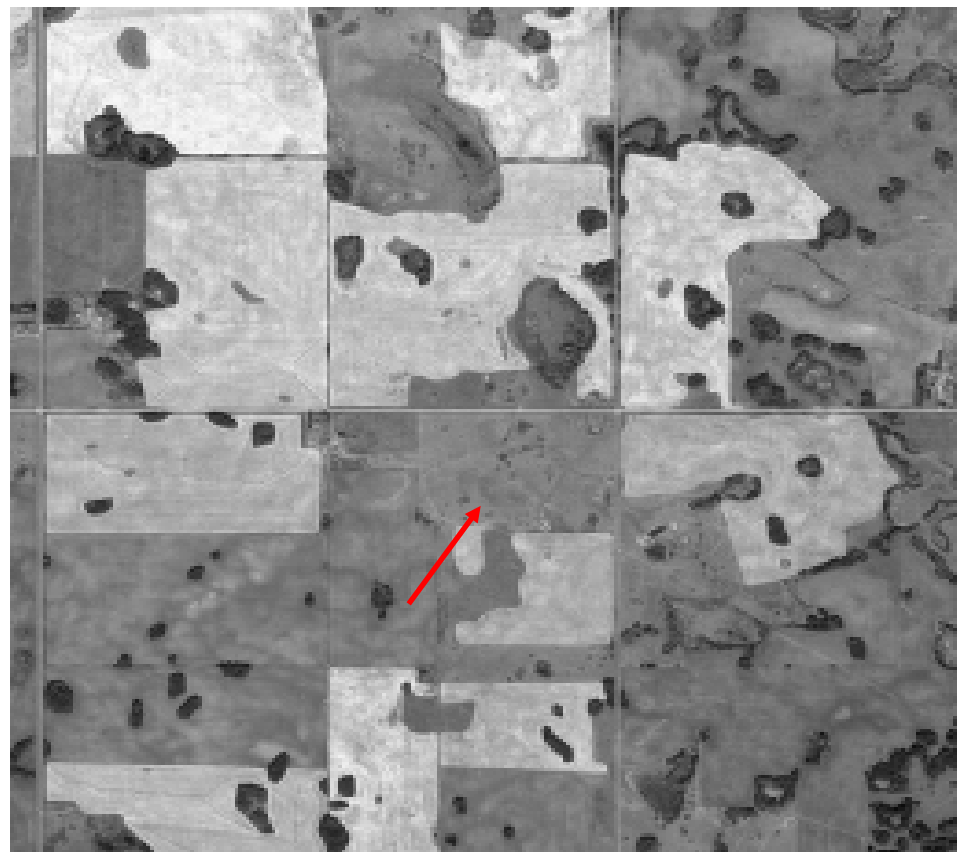
Historic Aerial: 33-44-13 W4M, September 17, 1967 (Image AS981). This image was taken approximately 13 years prior to the abandonment of Segment 1B.

KP 132.6 to KP 132.9: Temporary marsh (no previous concerns identified) and weeds noted in the quarter-section. The weed concern was noted during the PCEM of another pipeline ROW within the corridor and is likely unrelated to the abandonment of Segment 1B.

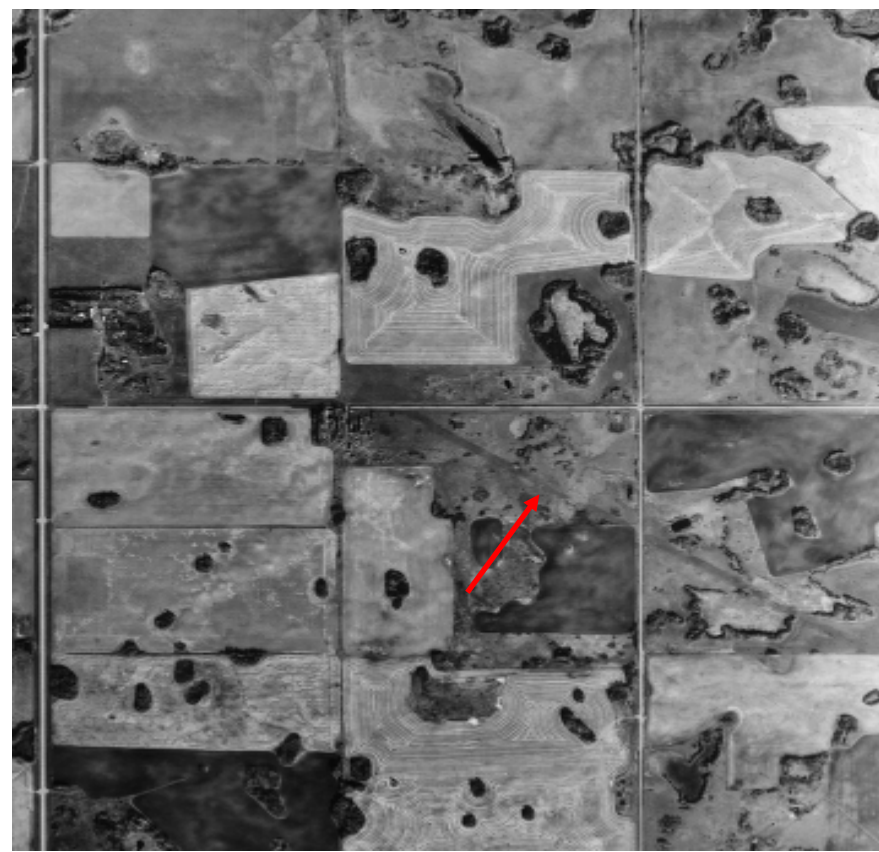
Historic Aerial: 33-44-13 W4M, October 17, 1996 (Image AS4774). This image was taken approximately 16 years following the abandonment of Segment 1B.

KP 132.6 to KP 132.9: Temporary marsh (no previous concerns identified) and weeds noted in the quarter-section. There is no evidence of change in the shape or size of the temporary marsh. The weed concern was noted during the PCEM of another pipeline ROW within the corridor and is likely unrelated to the abandonment of Segment 1B.

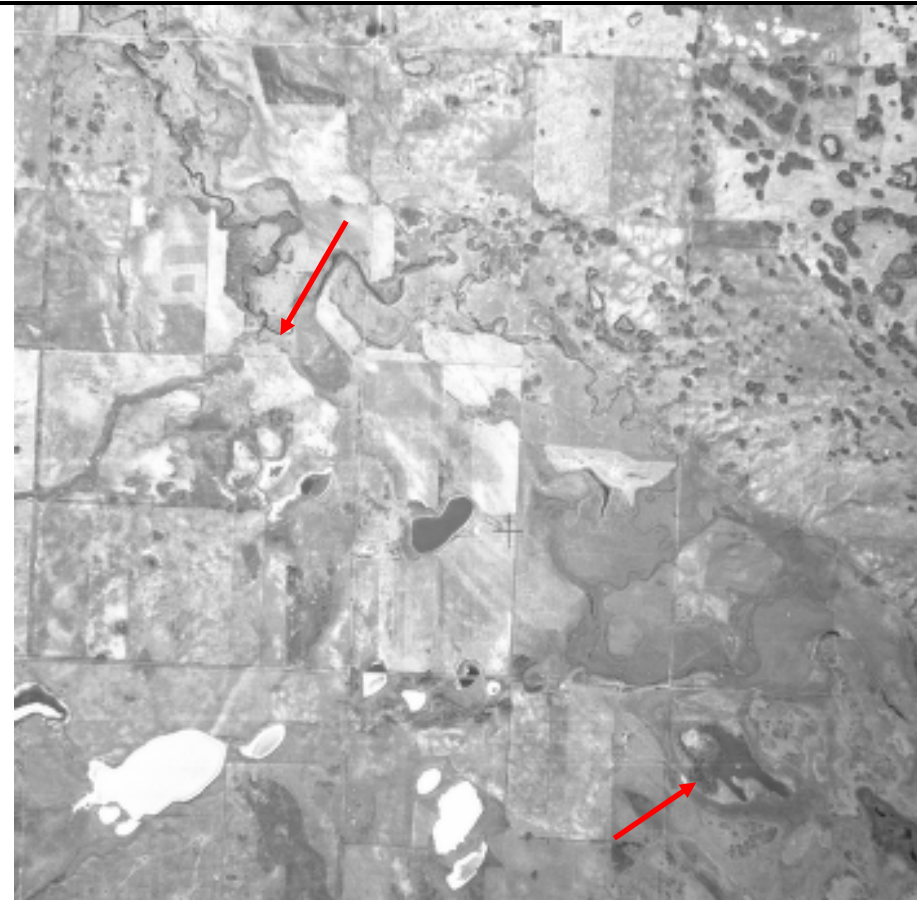
Historic Aerial: 26-44-13 W4M, September 13, 1949 (Image AS146). This image was taken approximately 31 years prior to the abandonment of Segment 1B.

KP 135.7 to KP 136.6: Intermittent, shallow, open water wetlands (weed issue observed in 2016). The intermittent wetlands are associated with an intermittent unnamed creek at this location.
