FINAL REPORT

Review of Previous Pipeline Abandonment Program – Phase 3 Abandonment on Farmland

Pipeline Abandonment
Research Steering
Committee

February 2019

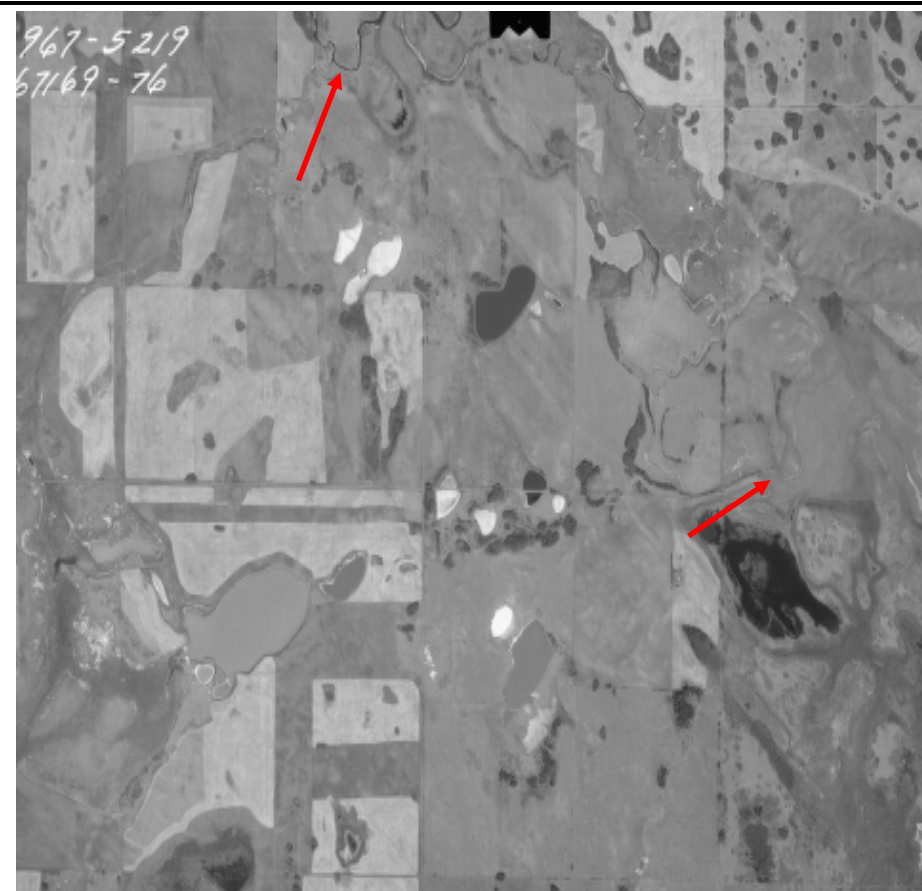
Historic Aerial: 25-44-13 and 19-44-13 W4M, September 17, 1967 (Image AS981). This image was taken approximately 13 years prior to the abandonment of Segment 1B.

KP 135.7 to KP 136.6: Intermittent, shallow, open water wetlands (weed issue observed in 2016). There may be evidence of altered hydrology of the creek after the crossing of the pipeline corridor (i.e., there appears to be less water in the channel); however, Segment 1B has not yet been abandoned in this image, so it cannot be attributed to the abandoned pipeline segment.

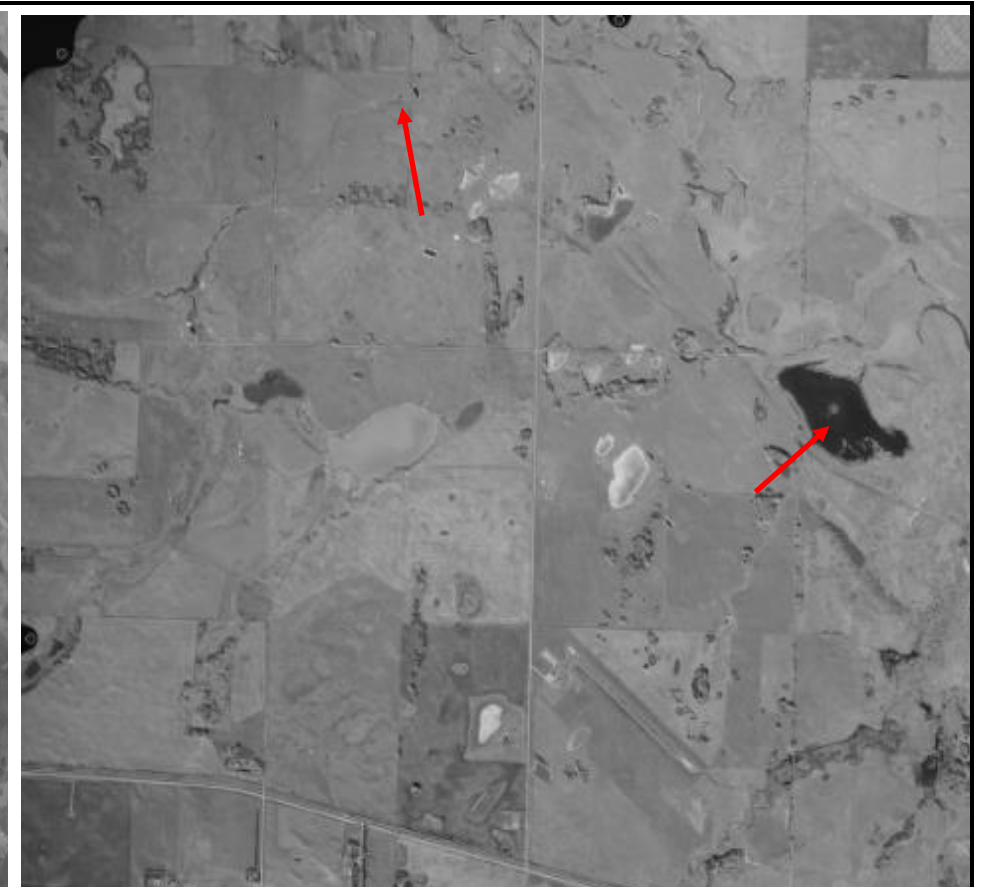
Historic Aerial: 26-44-13 W4M, October 23, 1998 (Image AS4981). This image was taken approximately 18 years after the abandonment of Segment 1B.

KP 135.7 to KP 136.6: Intermittent, shallow, open water wetlands (weed issue observed in 2016). There is no evidence of alternation of the size or shape of the intermittent, shallow, open water wetlands associated with the intermittent unnamed creek.

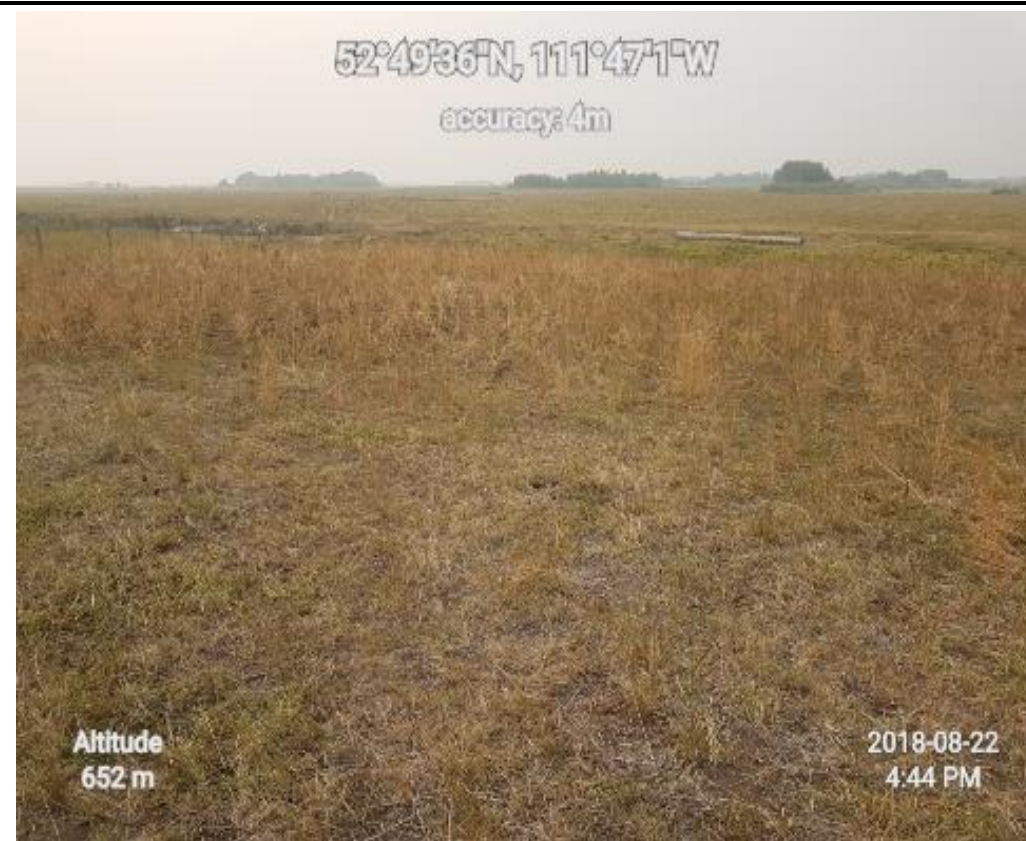
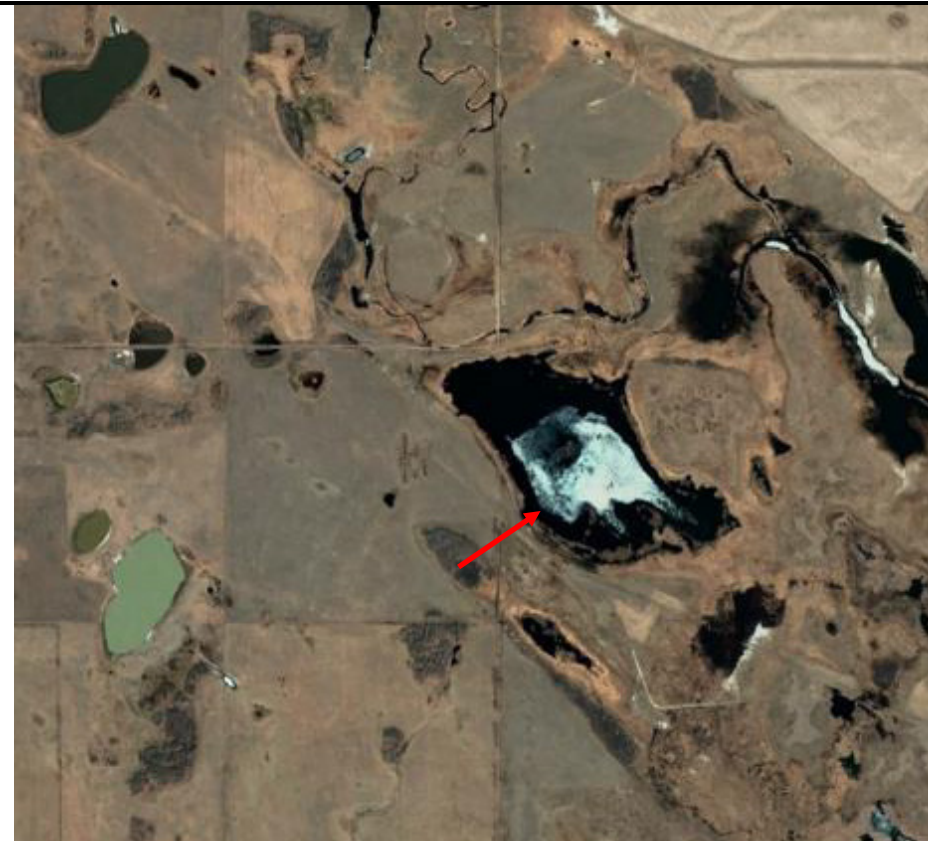
Photoplate: View northwest showing intermittent wetland at 26-44-13 W4M (12U 447201E 5853276N). This image was taken approximately 38 years after the abandonment of Segment 1B.

There is no evidence of the creek crossing the pipeline corridor; it appears to be cultivated through, as do the borders of the wetland.

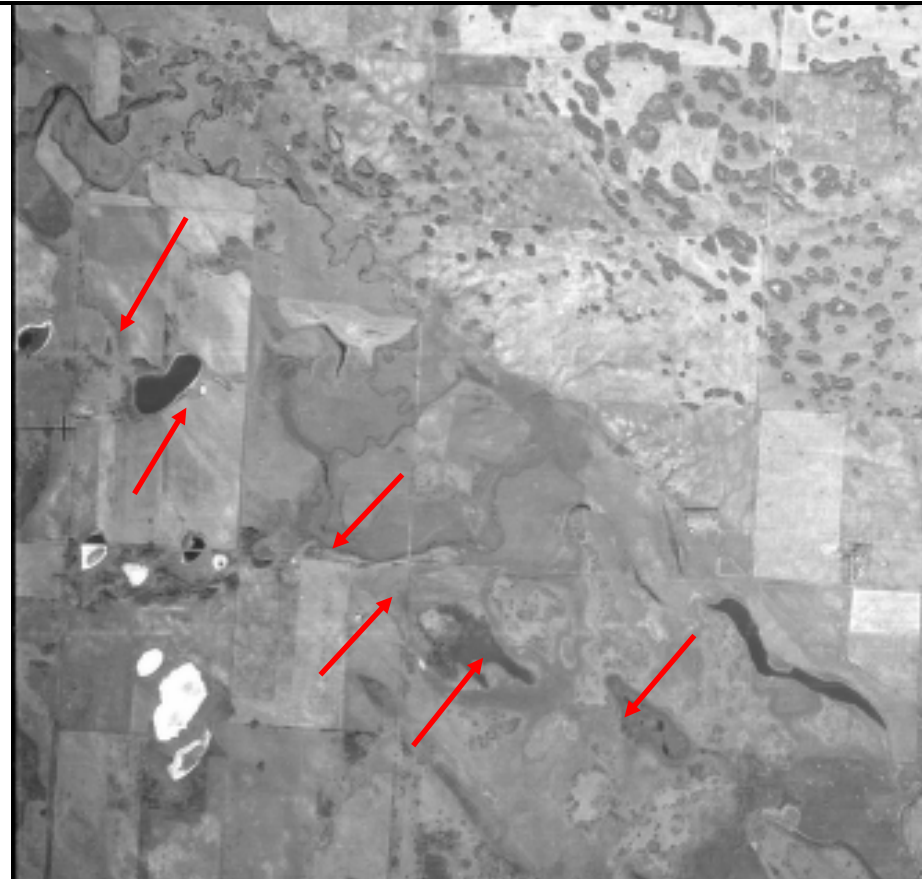
Historic Aerial: 19-44-12 W4M, September 13, 1949 (Image AS146). This image was taken approximately 31 years prior to the abandonment and removal of Segment 2A.

KP 138.1 to KP 138.2: Seasonal marsh wetland (no previous concerns identified) and cultivation noted to be poorly reseeded after pipe removal.

KP 139.0 to KP 139.0: Shallow, open water wetland, extremely wet areas noted during pipeline abandonment, and crossing berm location installed during pipeline abandonment.

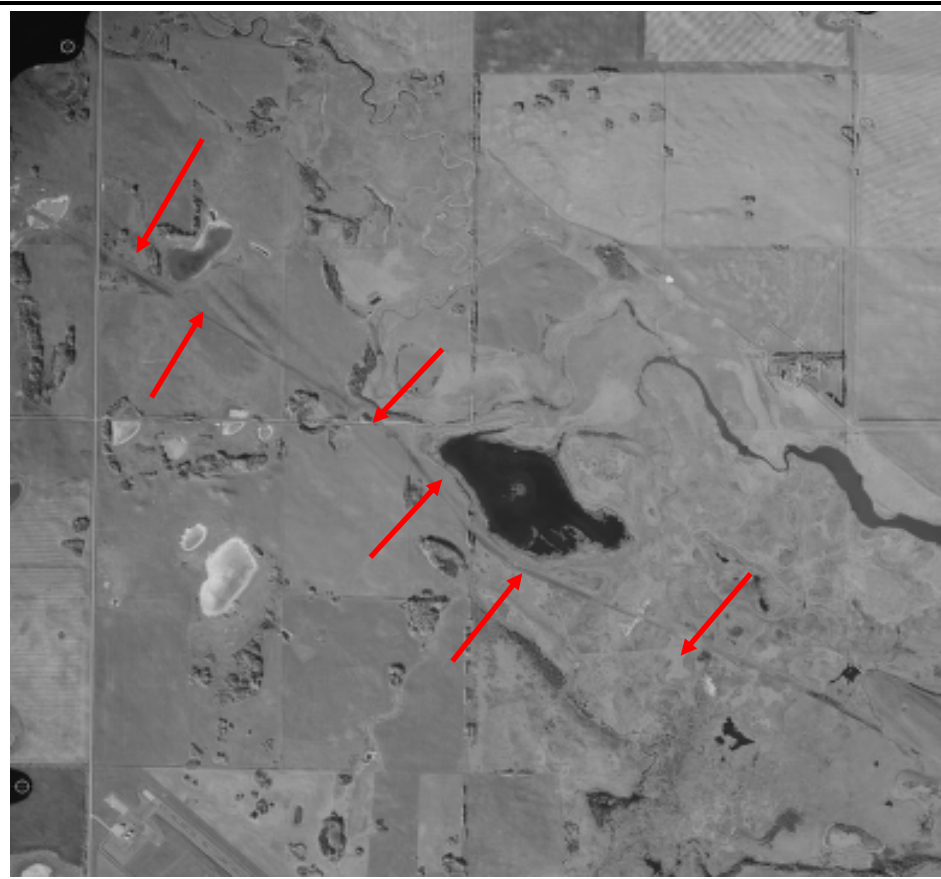
Historic Aerial: 19-44-12 W4M, October 23, 1998 (Image AS4981). This image was taken approximately 18 years after the abandonment and removal of Segment 2A.

KP 138.1 to KP 138.2: Seasonal marsh wetland (no previous concerns identified) and cultivation noted to be poorly reseeded after pipe removal. The size and shape of the seasonal marsh do not appear to be altered as a result of the abandonment and removal of Segment 2A.

KP 139.0 to KP 139.0: Shallow, open water wetland, extremely wet areas noted during pipeline abandonment, and crossing berm location installed during pipeline abandonment. The crossing berms appear to have prevented the alteration of the size or shape of the wetland once the abandoned pipeline segment was removed.

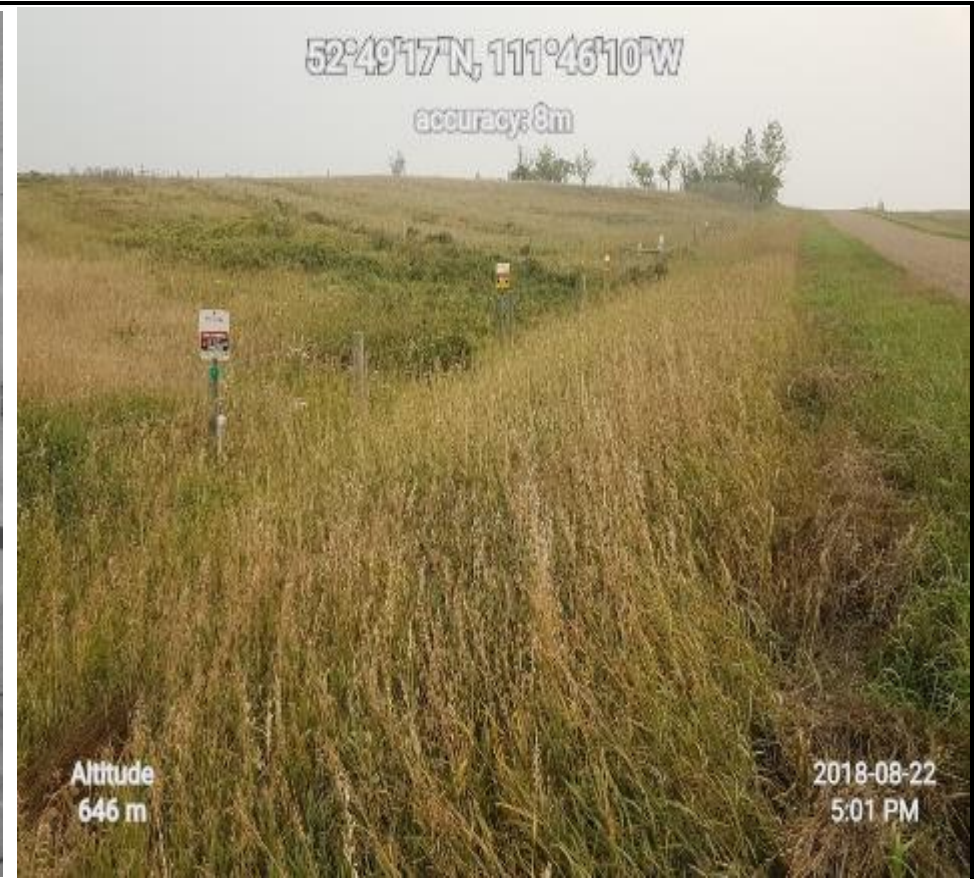
Photoplate: View south of start point of Segment 2A at KP 136.6; Highway 131 on the right of the photograph (12U 448149E 5852679N).

There does not appear to be any issues associated with the abandonment, excavation, and removal of Segment 2A.

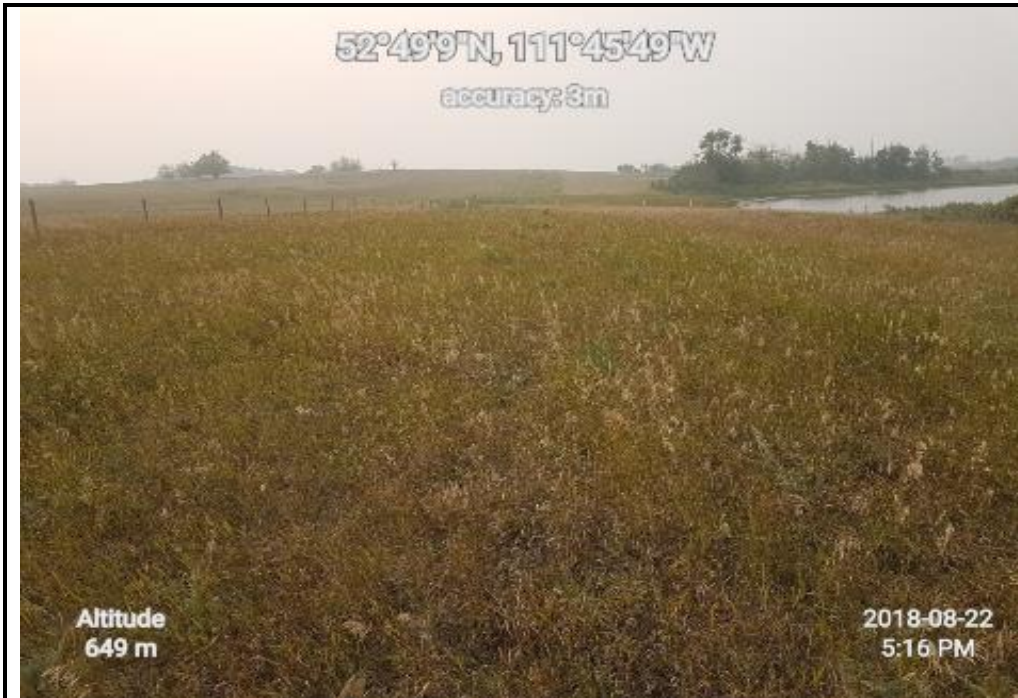
Photoplate: View northwest along ROW at KP 137.35 showing the shallow, open water wetland in the background (12U 448540E 5852427N). This image was taken approximately 38 years after the abandonment and removal of Segment 2A

There were no concerns noted along the pipeline corridor, as illustrated in this photograph.

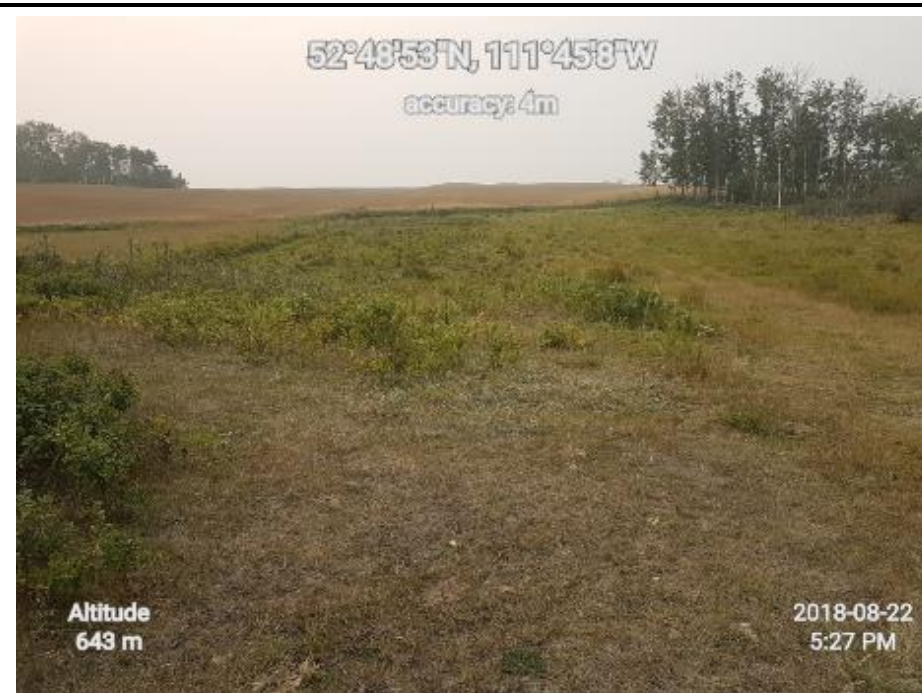
Photoplate: View southeast within seasonal marsh wetland area near KP 138.2 (12U 449302E 5851925N). This image was taken approximately 38 years after the abandonment and removal of Segment 2A.

The area was reported to be poorly reseeded upon completion of the abandonment, excavation, removal, and reclamation of Segment 2A. Evidence of poor revegetation remains apparent in this photograph.

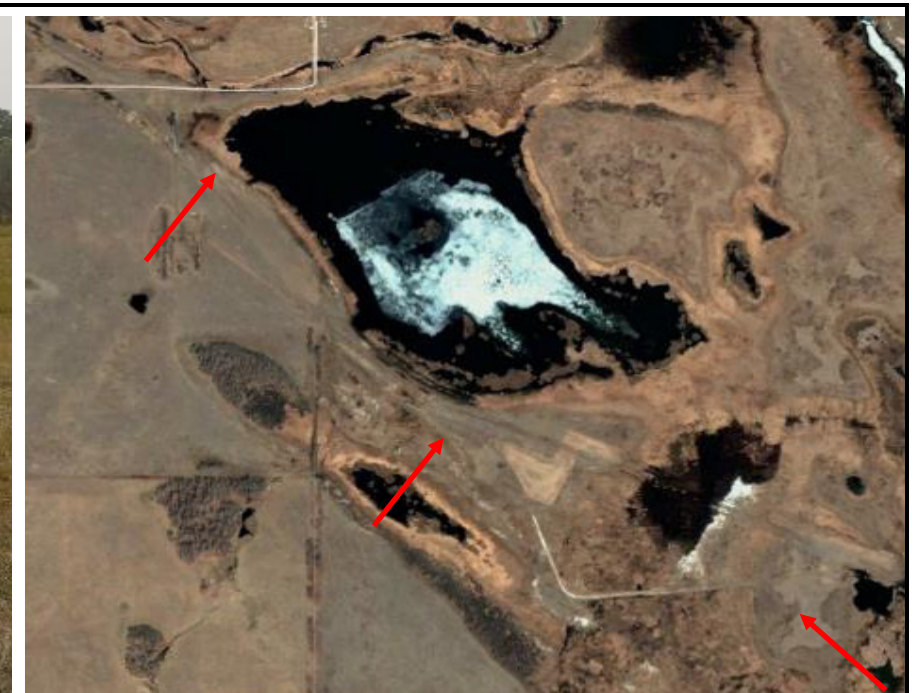
Photoplate: Aerial view of crossing berm location, shallow, open water wetland, and end point of Segment 2A (Google Earth, September 29, 2018). This image was taken approximately 38 years after the abandonment and removal of Segment 2A.

There is evidence of ponded water at the end point of Segment 2A. Further investigation of this location indicates subsidence across the entire corridor. The subsidence cannot be conclusively attributed to the abandonment of Segment 2A. There does not appear to be any evidence of stressed vegetation indicating that there were negligible amounts, if any, of product spilled during the purging of Segment 2A.

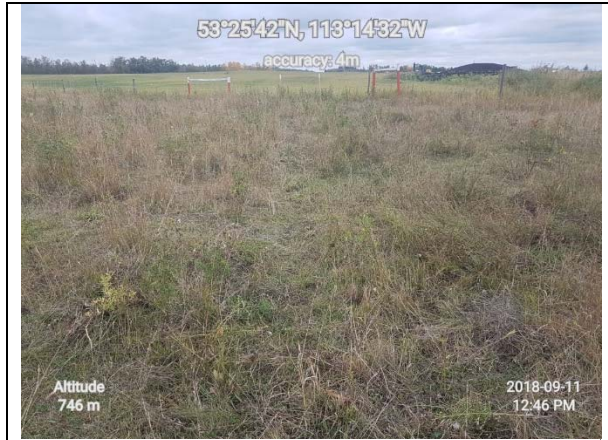
Plate D-1. View northwest along the abandoned pipeline segment showing the vegetated right-of-way (ROW) near Kilometre Post (KP) 14.5 at SW 30-51-22 W4M.

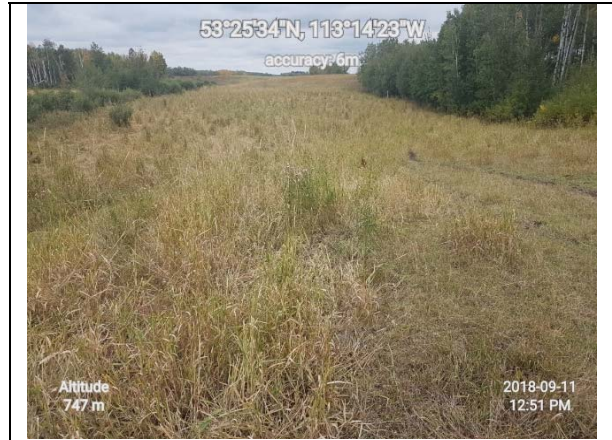
Plate D-2. View northwest of thick forage through a wetland area along the abandoned pipeline segment near KP 15.5 at SW 30-51-22 W4M.

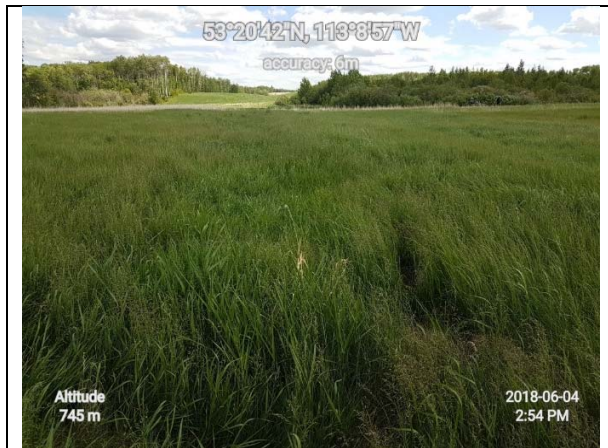
Plate D-3. View southeast along the abandoned pipeline segment showing the well-vegetated ROW near KP 26.3 at NE 28-50-22 W4M.

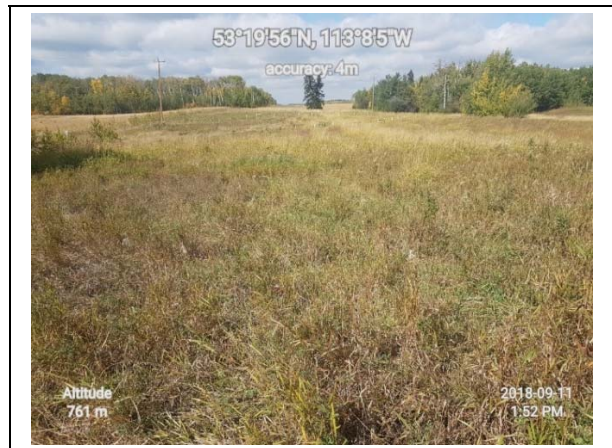
Plate D-4. View northwest along the abandoned pipeline showing healthy vegetation growing along the ROW near KP 27.5 at NE 22-50-22 W4M.

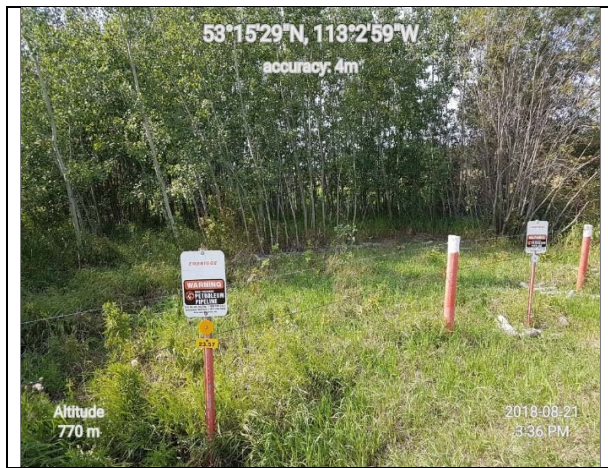
Plate D-5. View northwest of the abandoned pipeline segment showing tree regrowth adjacent to a road crossing near KP 38.2 at NE 30-49-21 W4M.

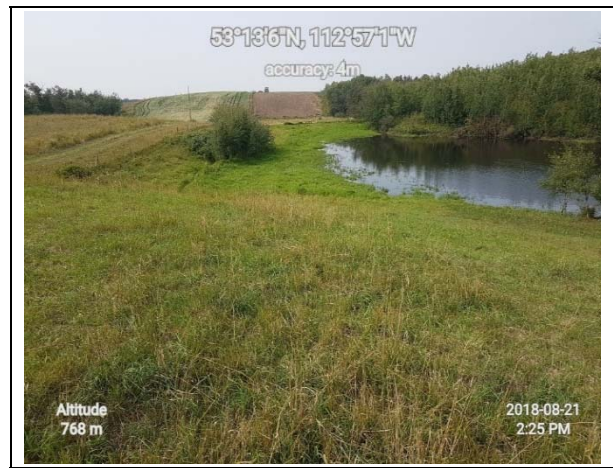
Plate D-6. View northwest across the abandoned pipeline segment showing a wetland to the east near KP 46.2 at NW 12-49-21 W4M.

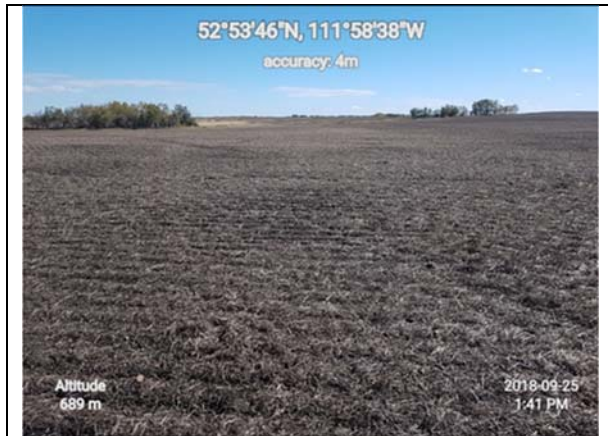
Plate D-7. View southeast across the abandoned pipeline segment near KP 120.8 at NW 21-45-14 W4M, also showing minor subsidence on the newer Line 3 to the right of the photograph.

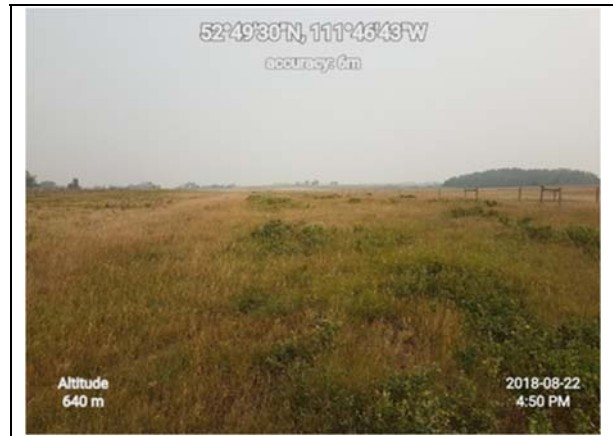
Plate D-8. View southeast along the abandoned pipeline segment showing a well-vegetated area near KP 136 at NW 26-44-13 W4M.

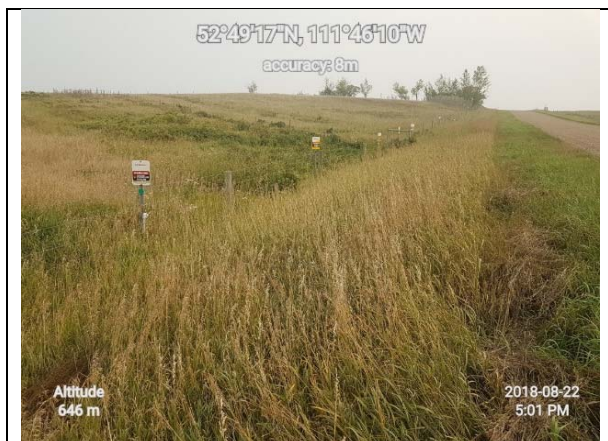
Plate D-9. View south along the abandoned pipeline segment near KP 136.7 at NE 26-44-13 W4M, where the removed segment begins.
